# 5 Lutwyche Street Higgins

Report Prepared: 30 April 2014

## PROPERTY DETAILS

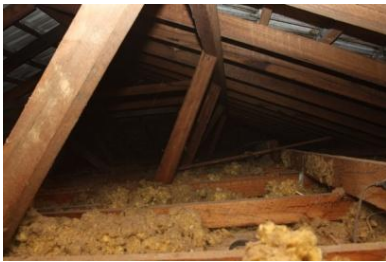
Roof Cavity

- insulation -
  - the roof cavity has been insulated with loose fill (blown) insulation
- sarking -
  - no sarking has been installed in the roof cavity
- roof construction -
  - cut hardwood construction
