PEST & BUILDING

REPORT

PROPERTY ADDRESS : 57 PAUL COE CRESCENT, NGUNNAWAL ACT 2913.
BLOCK & SECTION: BLOCK 7, SECTION 126, NGUNNAWAL.
BUILDING STYLE : SINGLE STOREY, BRICK VENEER, SLAB FLOOR, TILED ROOF.
OWNER'S NAME : JOEL & NATALIE GOODISSON.
OWNER'S SOLICITOR : PETER SIMONS / GUNGALIN LEGAL SERVICES.
AGENT : ROBYN EVANS / PETER BLACKSHAW REAL ESTATE - BELCONNEN.
INSPECTOR : GEORGE PUDJA.
DATE OF INSPECTION : MONDAY 03 JUNE 2013.
REPORT NUMBER : 7035.

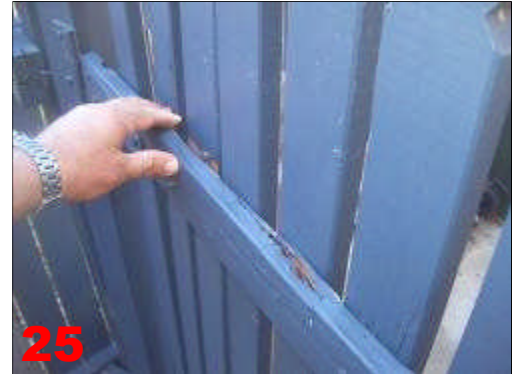
The timber gate to the right side showed evidence of damage and deterioration to the top rail which will require repair or replacement, and the loose palings obviously resecured. (See photo no. 25)

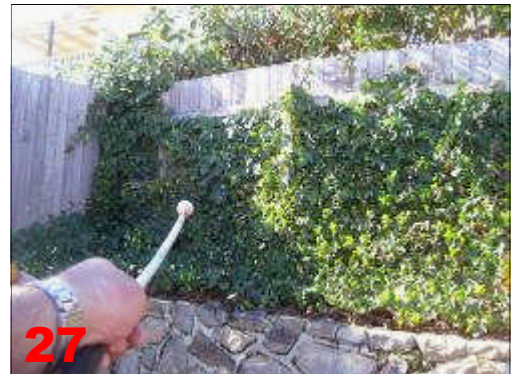
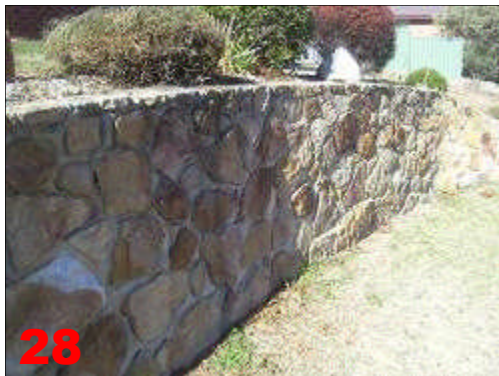
The stone retaining walls appeared to be in reasonable condition, and cracking in isolated areas at the rear is not a significant structural problem at this stage. However I am unable to comment on the provision of water control or other structural measures that are not visible. (See photo no. 28 & 29)

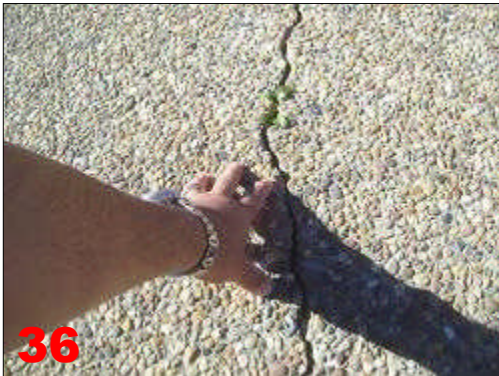
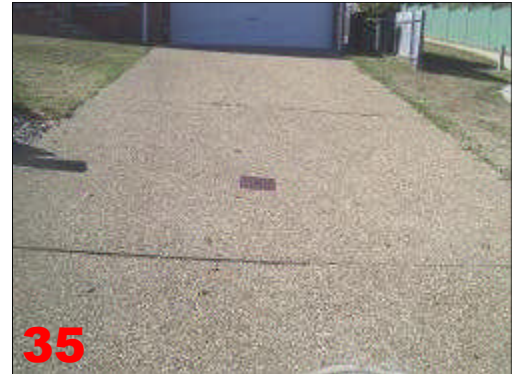
The driveway appeared to be in reasonable condition, and cracking in isolated areas is not a significant structural problem at this stage, but if further movement occurs and the cracks become a trip hazard, some repair work would obviously be needed then. (See photo no. 35 & 36)

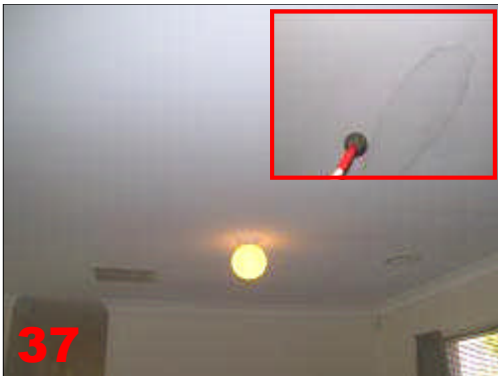
The ceiling lining appeared to be in reasonable condition, although there was a watermark to the family room ceiling, which may indicate previous leakage, however moisture meter readings indicated nothing unusual, which would suggest this is not a current issue, but this would need to be confirmed during heavy rain, and some additional patching and painting will be needed for a professional finish. (See photo no. 37)

- **The ceiling lining** appeared to be in reasonable condition, although there was a watermark to the family room ceiling, which may indicate previous leakage, however moisture meter readings indicated nothing unusual, which would suggest this is not a current issue, but this would need to be confirmed during heavy rain, and some additional patching and painting will be needed for a professional finish.

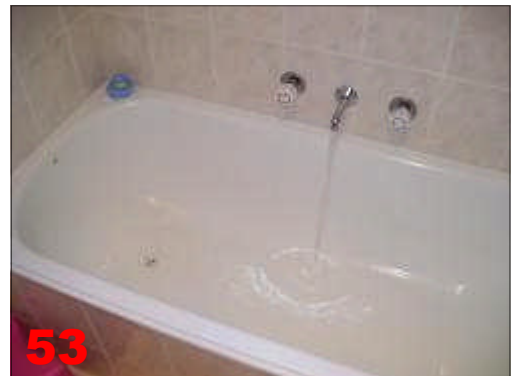
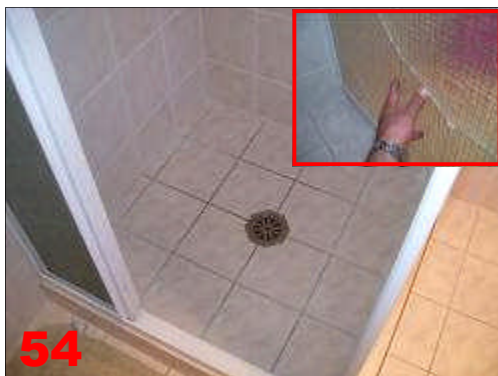
The bathroom shower showed no evidence of moisture or tiling problems at the time of inspection. The glass to the shower screen was cracked and although it did not appear to be loose, it may require replacement. (See photo no. 54)

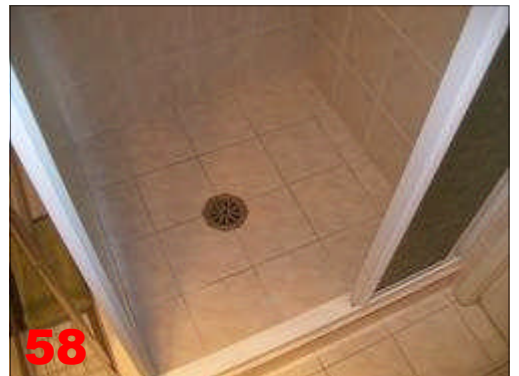
58

The ensuite shower showed no evidence of moisture or tiling problems at the time of inspection. The glass to the shower screen was cracked and although it did not appear to be loose, it may require replacement. The shower screen doors were operable, but the centre door is missing a clip that prevents the doors sliding past on another, but this could be easily rectified. (See photo no. 58, 59 & 60)

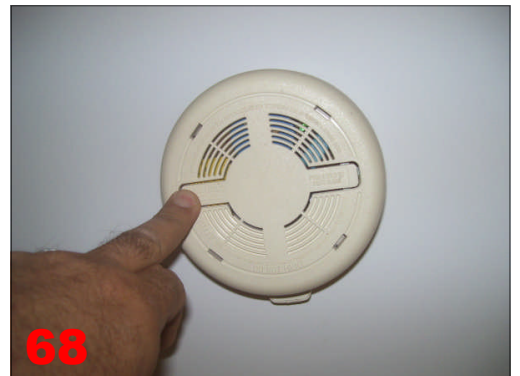
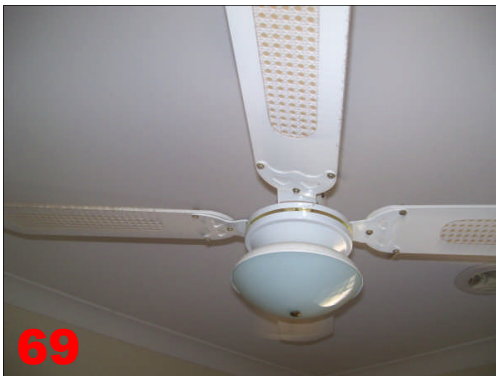
The smoke detectors were tested, although were not operable and may require new batteries. (See photo no. 68)

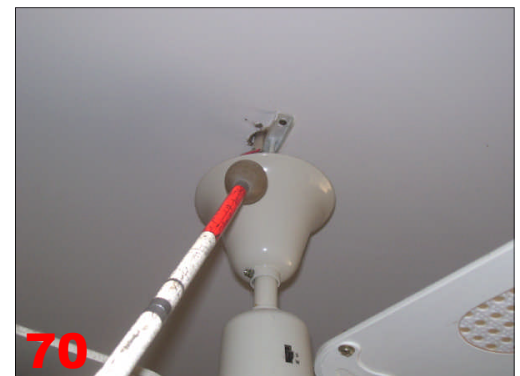
The ceiling fan in the master bedroom was tested and found to be operable at the time of inspection, however top cover has slipped down, but this could be easily adjusted. (See photo no. 69 & 70)
