INTEGRATED BUILDING
AND INSPECTION SERVICES

WE PRIDE OURSELVES ON THE QUALITY INSPECTIONS AND REPORTS WE PRODUCE !

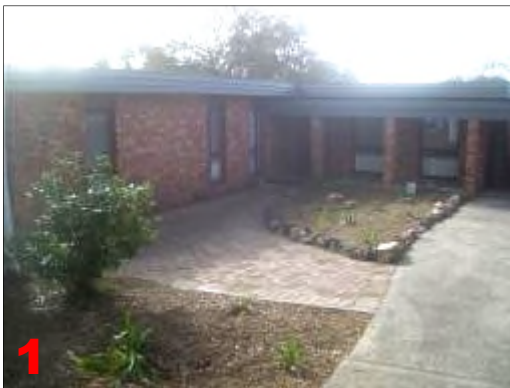
The property is situated in the quiet cul-de-sac of Mainoru Place which runs off Tanumbirini Street . The house is orientated on a Northwest/Southeast axis, with the front facing Northwest and the land sloping naturally from front to back.

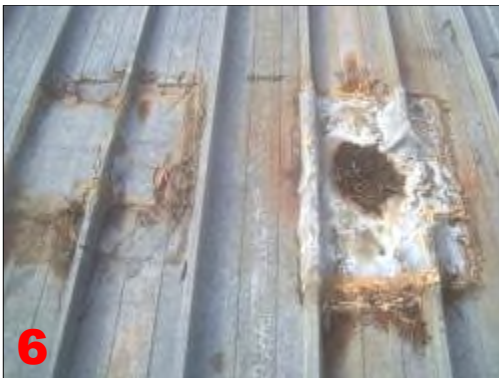
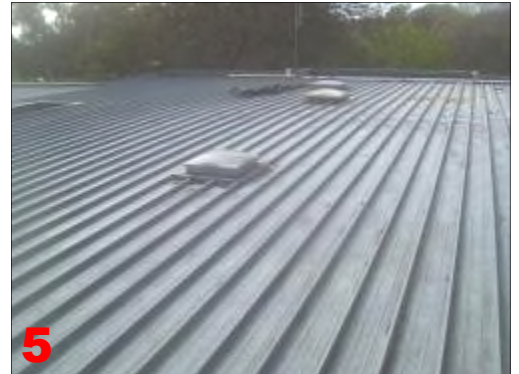
The flashing around the skylights showed no evidence of excessive cracking or leakage at the time of inspection. (See photo no. 7)

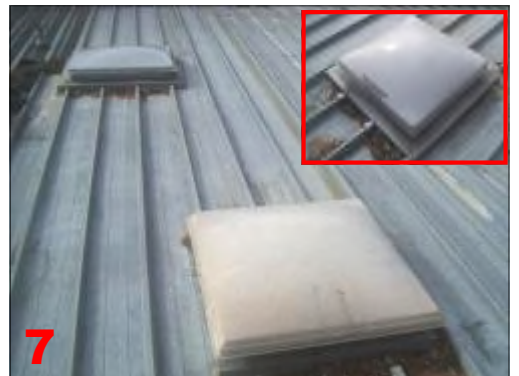
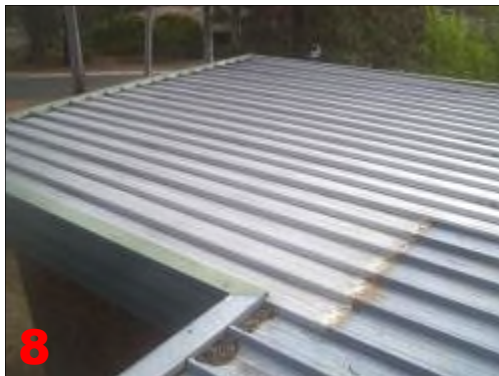
The metal deck roofing to the extensions were in good condition with no obvious faults at the time of inspection, and although there were no obvious signs of leakage, confirmation of whether a roof leaks or not can only be done during heavy rain. (See photo no. 8 & 9)

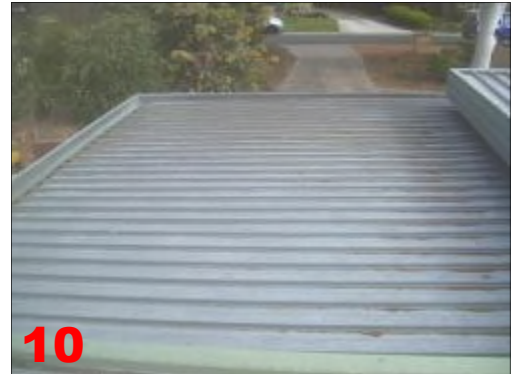
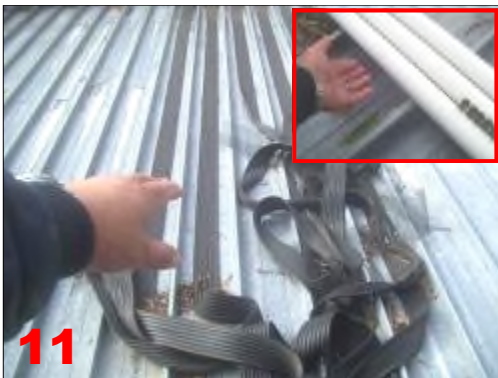
The swimming pool heating system had sections that were disconnected from the pipes. The system was not tested at the time of inspection. (See photo no. 11)

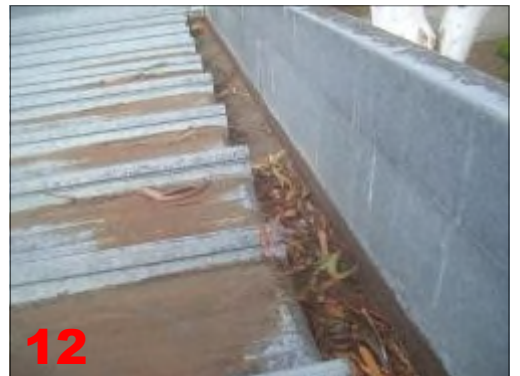
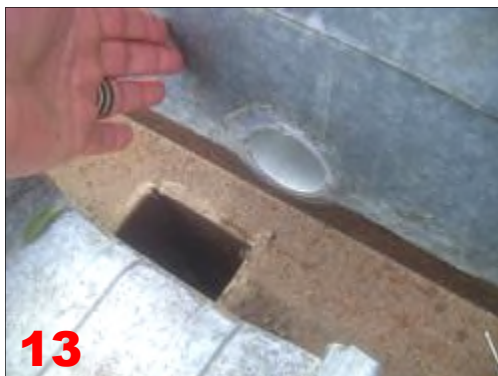
Additional overflows have been fitted to the gutters which suggests there have been issues with the gutters previously. (See photo no. 13)

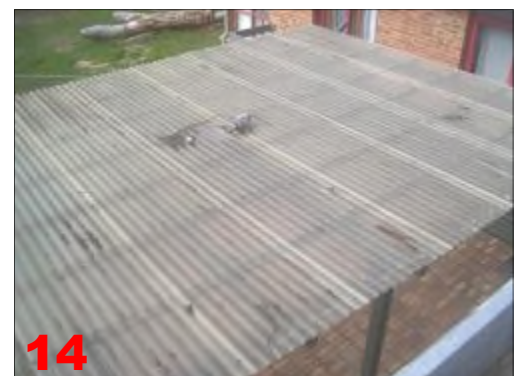
The polycarbonate roof sheeting over the pergola appeared to be in good condition, with no obvious faults at the time of inspection. It should also be noted that confirmation of whether a roof leaks or not can only be done during heavy rain. (See photo no. 14)

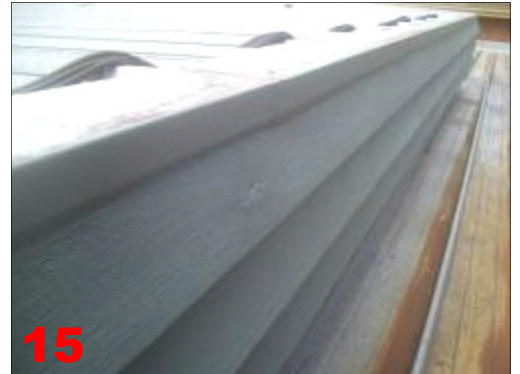
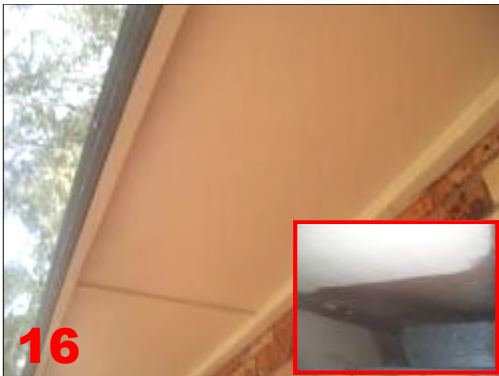
The **plywood eaves and soffit lining** were in good condition, with no excessive sagging or loose trims at the time of inspection. (See photo no. 16)

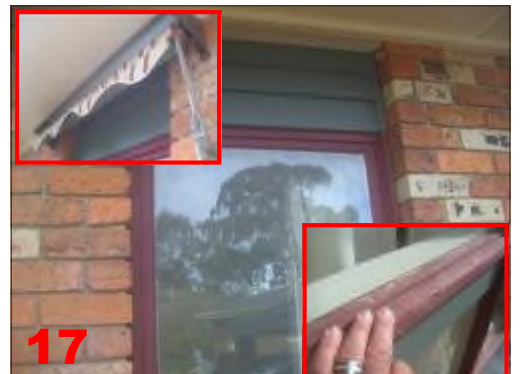
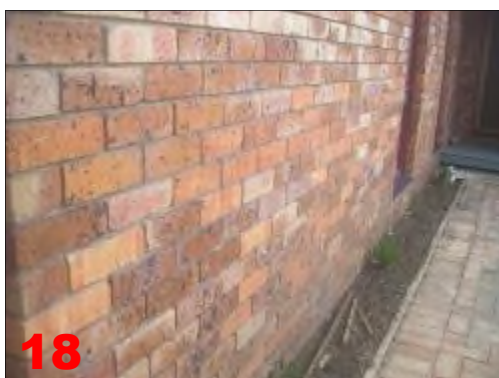
The **brickwork** appeared to be in good condition, with no significant structural cracking at the time of inspection. The garden bed levels against the walls of the house should be kept low and not allowed to cover weep holes or vents, as this can lead to ventilation, pest and moisture issues. (See photo no. 18 & 19)

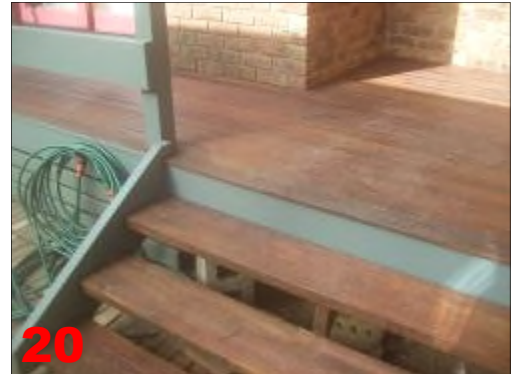
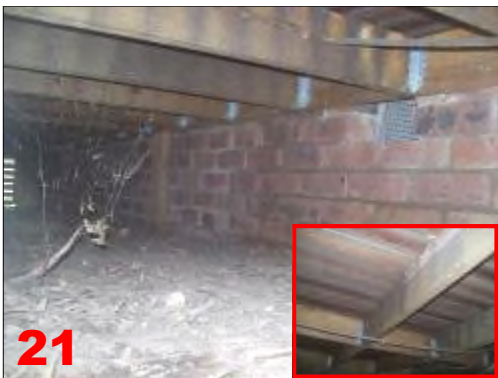
The rear timber deck attached to the main house generally appeared to be in reasonably good condition, although there is water damage to some of the elements in contact with the ground, and maintenance and repairs may be required. It should also be noted that all timber elements in contact with the ground are susceptible to pest and water problems and should be monitored on a regular basis. (See photo no. 22 & 23)

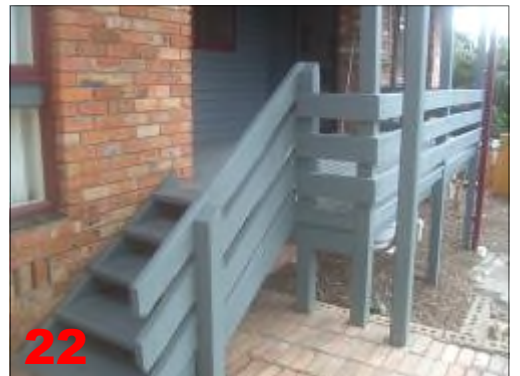
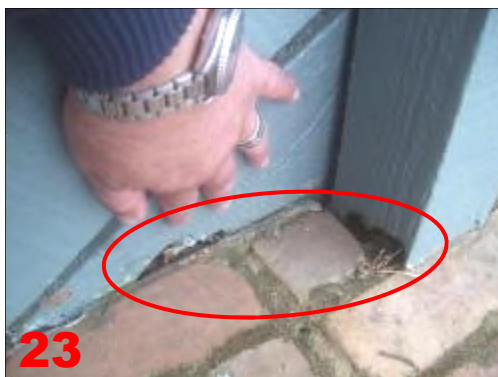
The underside of the rear timber deck attached to the main house appeared to be in good condition, with no evidence of excessive pest or water damage at the time of inspection. (See photo no. 24)

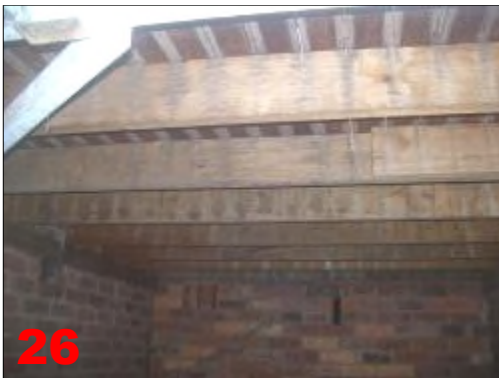
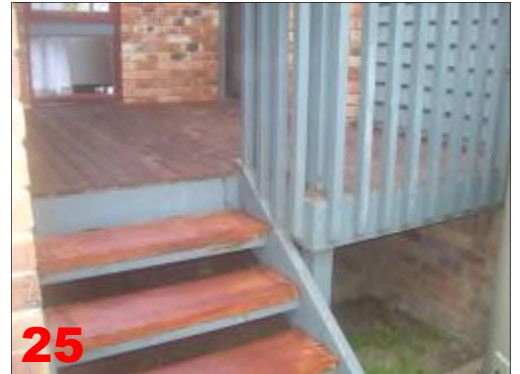
The timber decking to the front porch appeared to be in good condition, with no evidence of excessive pest or water damage at the time of inspection. The underside of the timber decking was not accessible for inspection, and therefore no comment can be made regarding the condition of this area. It should also be noted that all timber elements in contact with the ground are susceptible to pest and water problems and should be monitored on a regular basis. (See photo no. 27)

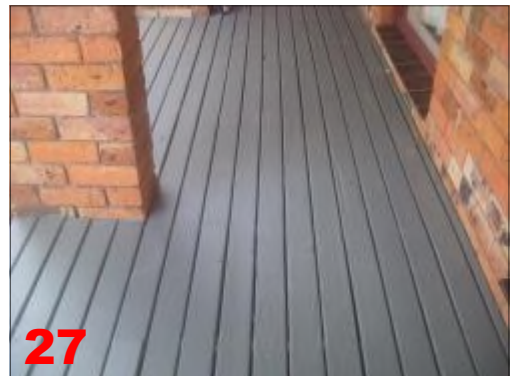
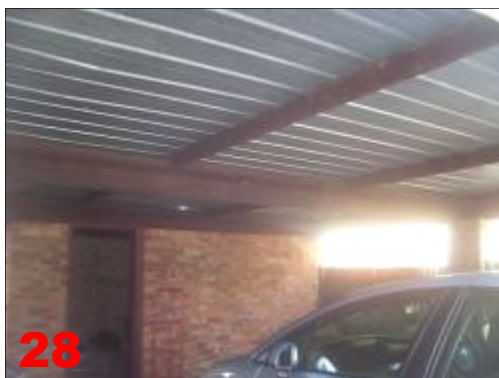
The metal carport and attached store room appeared to be in good condition, with no significant structural faults at the time of inspection. (See photo no. 28 & 29)

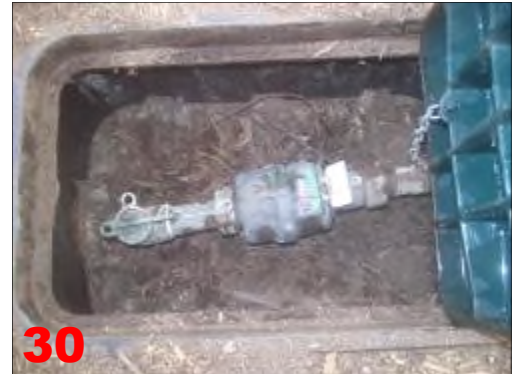
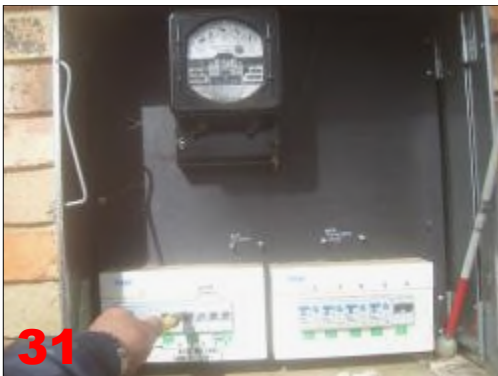
The electrical meter box was inspected and the switches and fuses were found to be active, although a licensed electrician would be required to determine the compliance or otherwise of the electrical system.
(See photo no. 31)

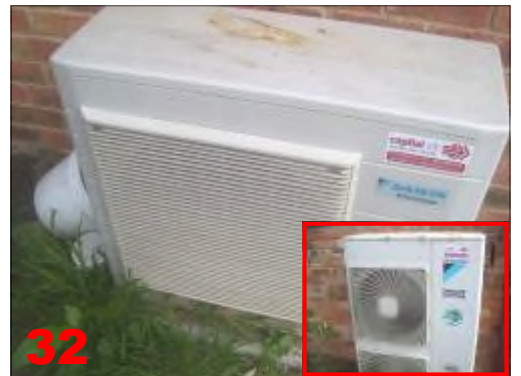
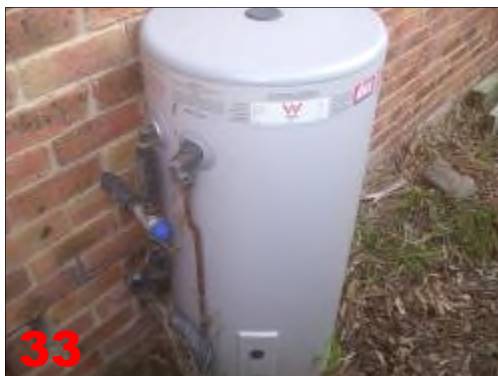
The electric hot water units were operable, with no obvious leakage at the time of inspection. The relief valves were tested and found to be in operable condition; however a licensed plumber would be required to determine the service condition of the units and their various components.
(See photo no. 33 & 34)

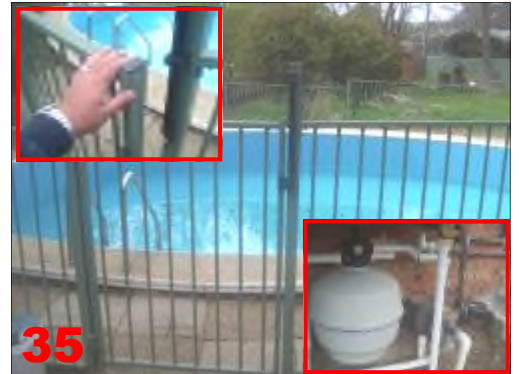
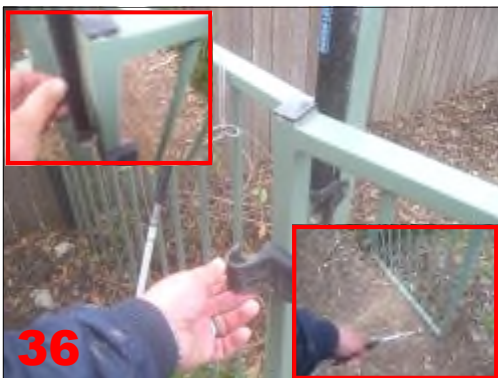
One of the gates will require adjustment to prevent sticking, along with the soil below to be removed, for proper operation. (See photo no. 36)

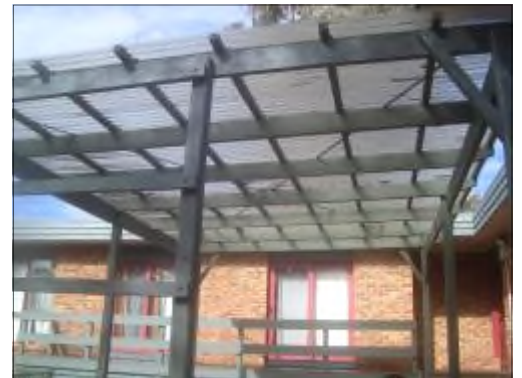
The timber pergola appeared to be in good condition, with no evidence of excessive pest or water damage at the time of inspection. (See photo no. 37)

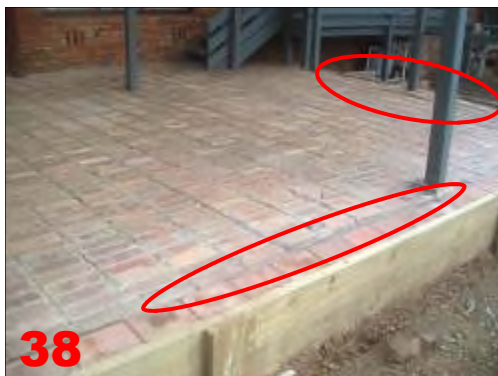
The paving to the rear yard appeared to be in reasonable condition, although there were areas where it was uneven and consideration should be given to re-laying if it becomes a trip hazard. The timber sleepers surrounds showed evidence of normal weathering, although there was no evidence of current pest infestation or damage at the time of inspection. However, all timber elements in contact with the ground are susceptible to pest and water problems and should be monitored on a regular basis. (See photo no. 38)

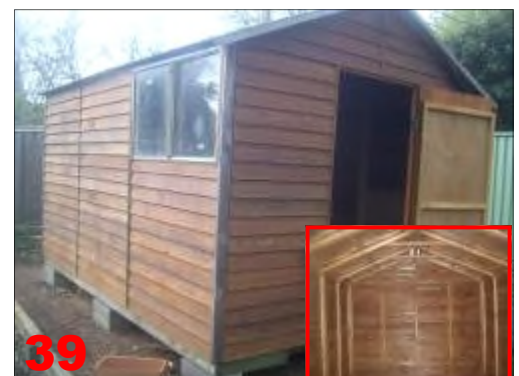
The timber garden shed showed evidence of normal weathering, although there was no evidence of current pest infestation or damage at the time of inspection. (See photo no. 39)

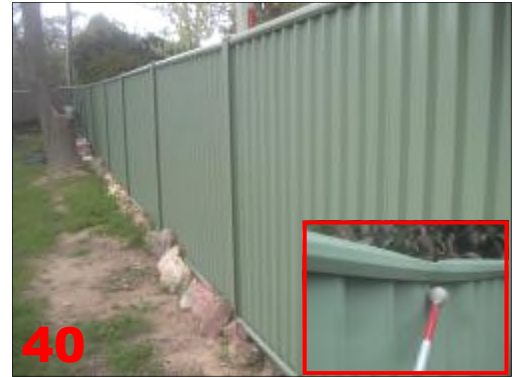
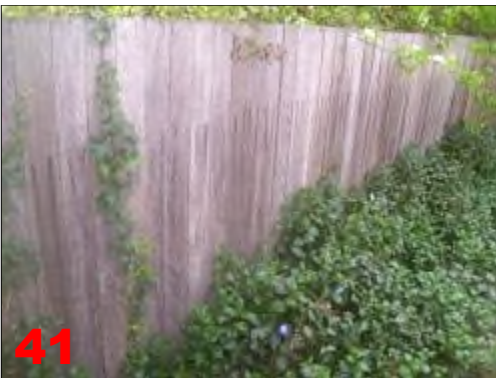
The older timber fences that were unobstructed appeared to be in reasonable condition, although some sections were obscured by vines and bushes, making inspection impossible in those areas. It should also be noted that most timber fences over 20 years old need some maintenance and repairs and vines may provide cover for unseen pests and periodic monitoring is recommended. All timber elements in contact with the ground are susceptible to pest and water problems and should be monitored on a regular basis. (See photo no. 41)

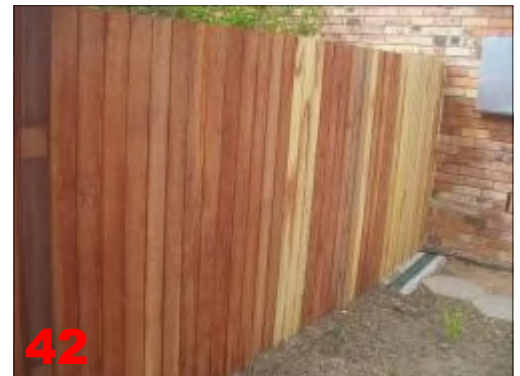
The new timber boundary fences showed evidence of normal weathering, although there was no evidence of current pest infestation or damage at the time of inspection. However, all timber elements in contact with the ground are susceptible to pest and water problems and should be monitored on a regular basis. (See photo no. 42)

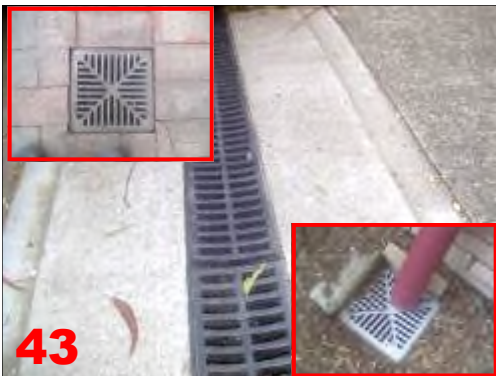
The ground sumps and grated drains showed no evidence of excessive debris or blockages at the time of inspection, although an effort should be made in keeping these items clean to avoid potential blockages and surface water issues. (See photo no. 43)

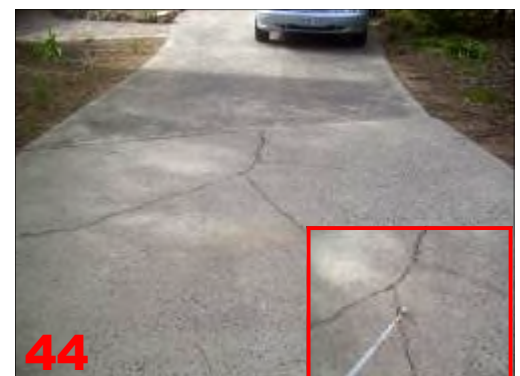
The driveway appeared to be in reasonable condition, and cracking in isolated areas is not a significant structural problem at this stage, but if further movement occurs and the cracks become a trip hazard, some repair work would obviously be needed then. (See photo no. 44)

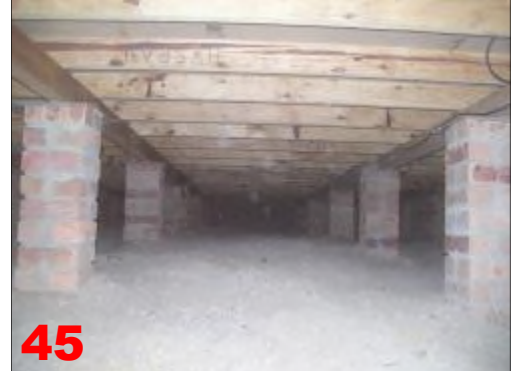
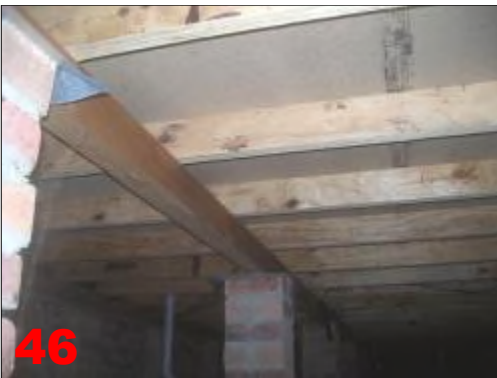
The bearers and joists appeared to be in good condition, with no evidence of structural or pest problems at the time of inspection. (See photo no. 46)

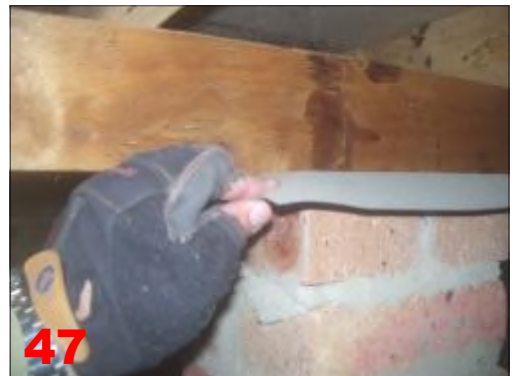
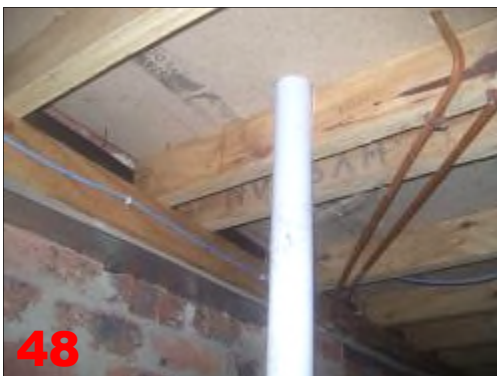
The drainage pipes under the kitchenette area showed no evidence of current leakage at the time of inspection. (See photo no. 48)

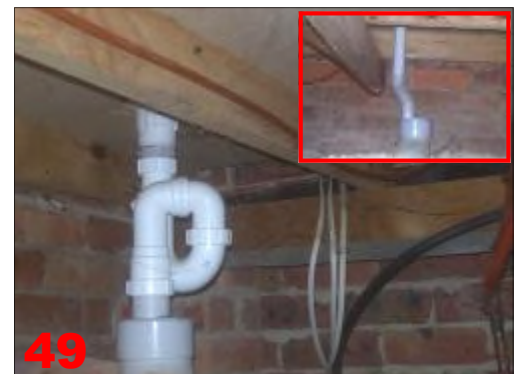
The drainage pipes under the ensuite 3 area showed no evidence of current leakage at the time of inspection. (See photo no. 49)

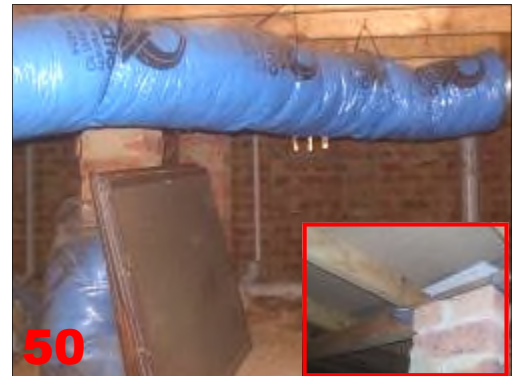
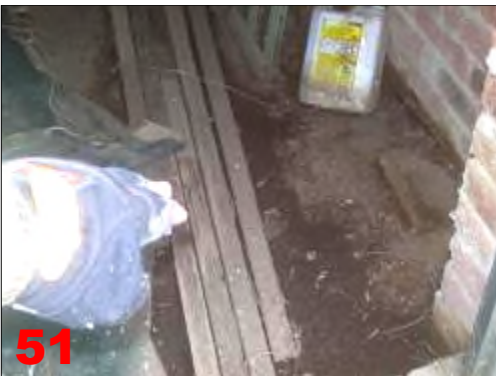
Timber materials located in the subfloor area are susceptible to pest problems and should be removed if possible, particularly where there is some moisture in the soil. (See photo no. 51)

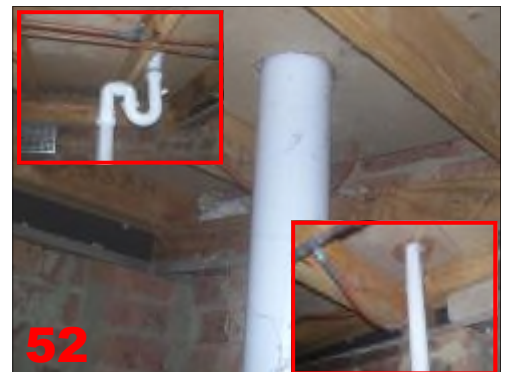
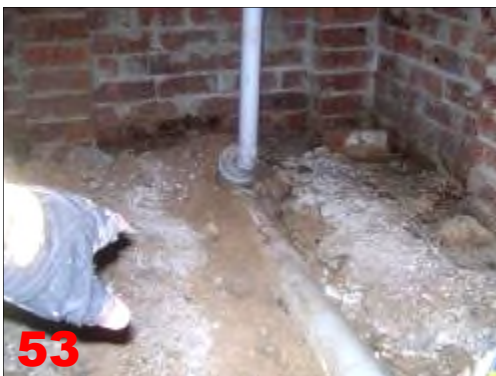
There were water trails in the subfloor that suggests some previous surface water seepage, but the extent would need to be verified during rain periods, although I don't consider this to be particularly significant as it could be easily addressed with external drainage improvements. (See photo no. 53 & 54)

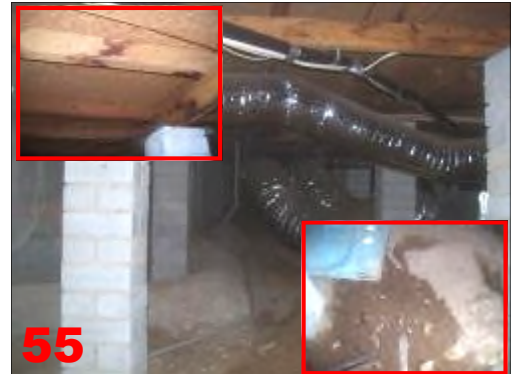
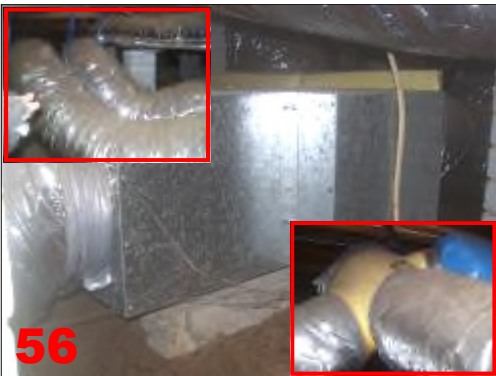
The ducted heating unit showed no obvious faults externally at the time of inspection, although a licensed technician would be needed to determine the service condition of the unit and system as a whole. The heating ducts appeared to be in reasonable condition, although the number and size of the ducts tends to restrict access to some areas, making inspection difficult in those areas. (See photo no. 56)

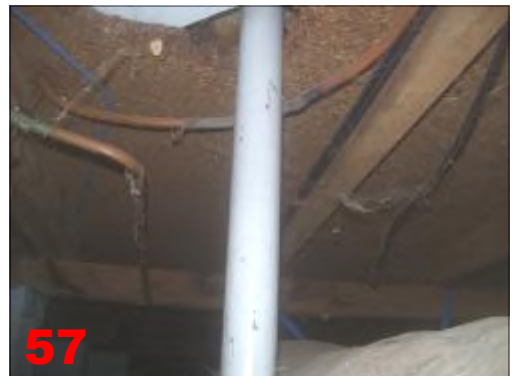
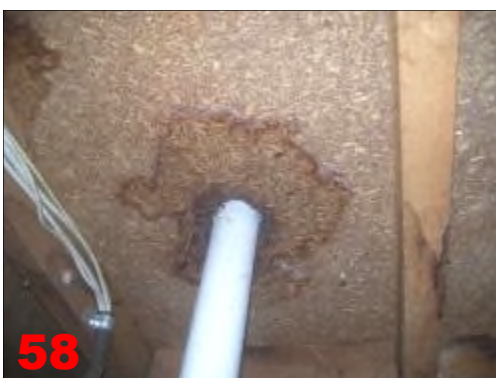
The drainage pipes under the laundry area showed no evidence of current leakage at the time of inspection., although there was evidence of old water marks, which may indicate a previous leakage issue. (See photo no. 58)

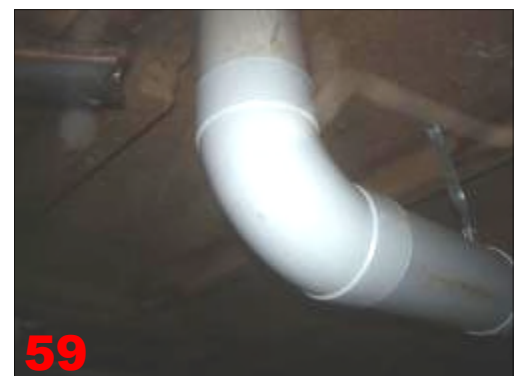
The drainage pipes under the bathroom WC area showed no evidence of current leakage at the time of inspection. (See photo no. 59)

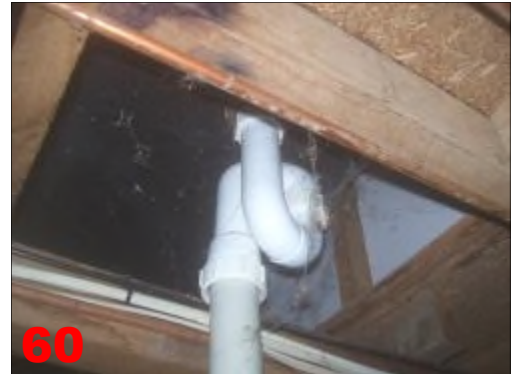
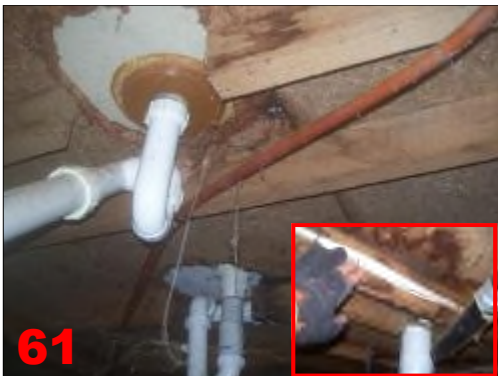
The drainage pipes under the bathroom shower area showed no evidence of current leakage at the time of inspection, although there was evidence of old water marks, which may indicate a previous leakage issue. (See photo no. 61)

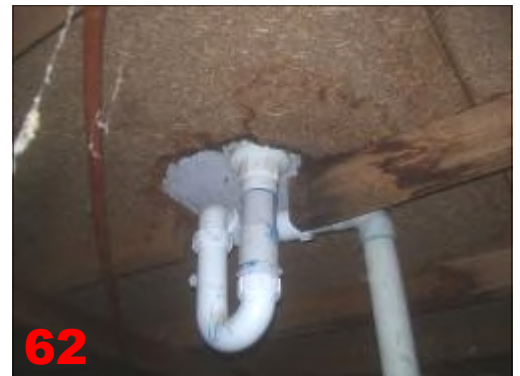
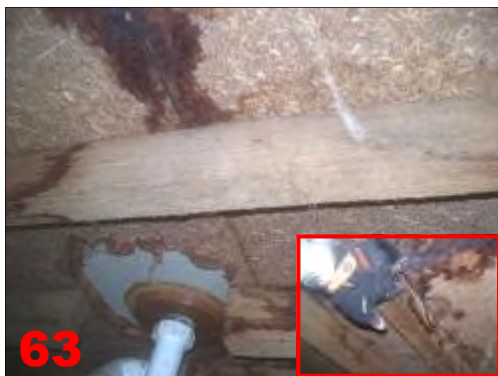
The old electric hot water unit located in the main house subfloor appeared to be disconnected and no longer in use. (See photo no. 64)

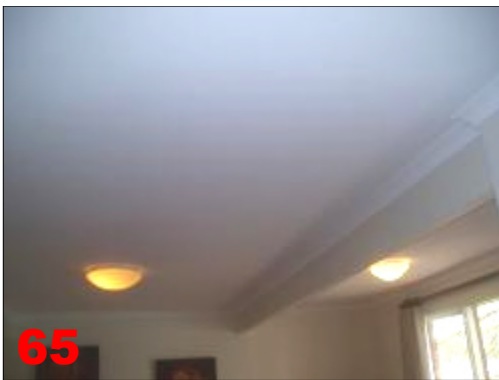
The ceilings and cornices showed no sagging or cracking at the time of inspection. (See photo no. 65)

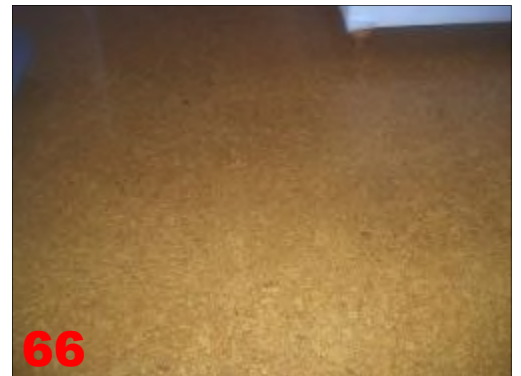
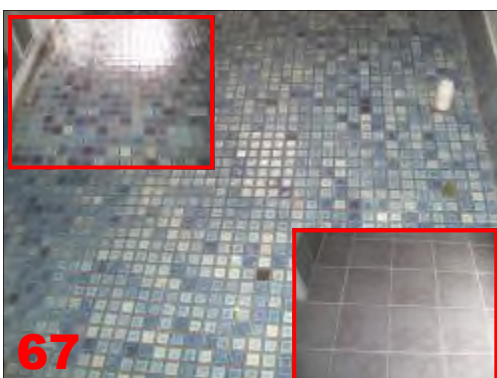
The tile floor finishes showed no excessive lifting or cracking at the time of inspection. (See photo no. 67)

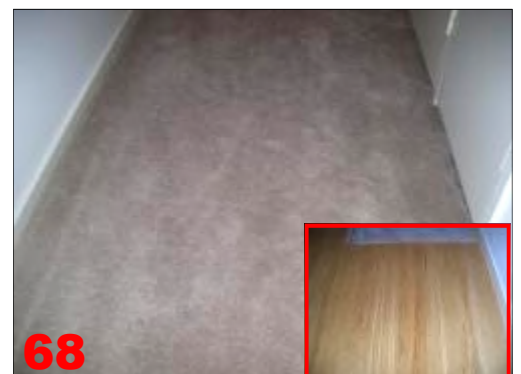
The carpet floor finishes showed no excessive staining or wear marks at the time of inspection. **The floating timber floor finishes** showed no obvious faults and no evidence of pest or water damage at the time of inspection. (See photo no. 68)

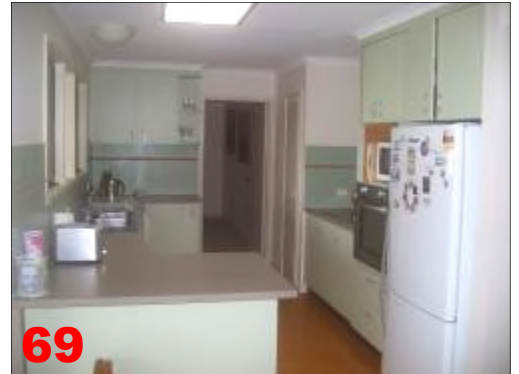
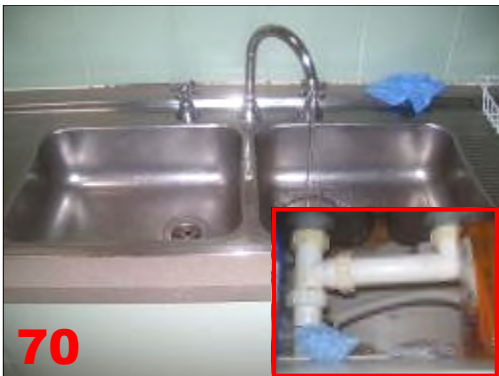
The kitchen sink was tested and the plumbing found to be operable, with no evidence of leakage at the time of inspection. (See photo no. 70)

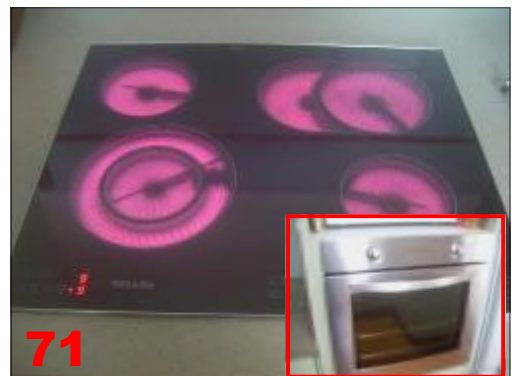
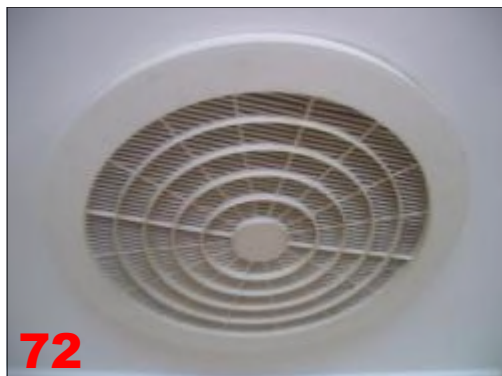
The kitchen exhaust fan was operable when tested at the time of inspection. (See photo no. 72)

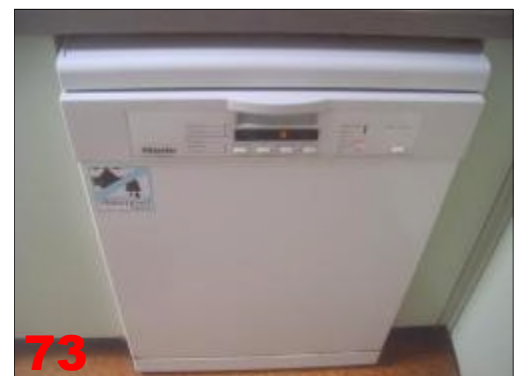
The dishwasher showed no evidence of leakage and no excessive cracking to the door seal, although the unit was not tested at the time of inspection. (See photo no. 73)

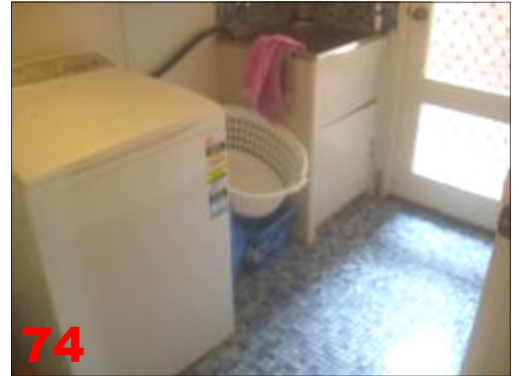
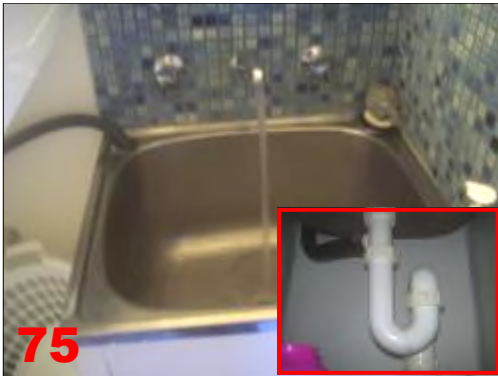
The laundry tub was tested and the plumbing found to be operable, with no evidence of leakage at the time of inspection. (See photo no. 75)

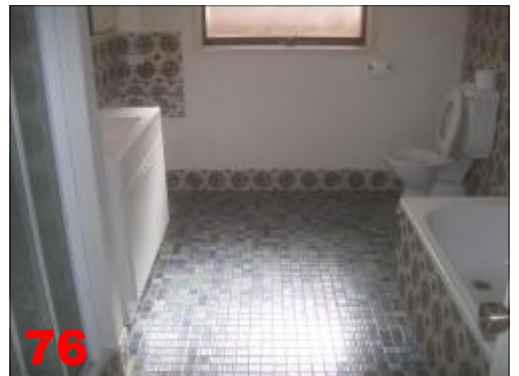
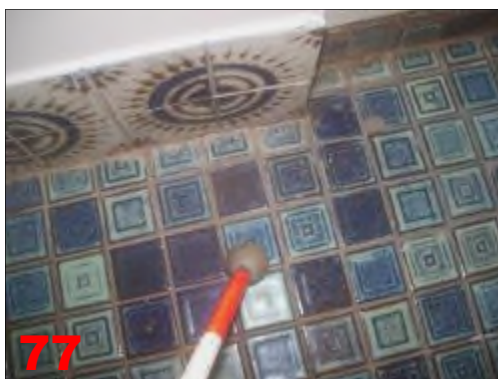
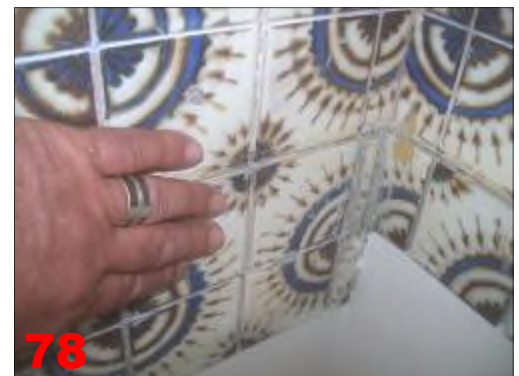
The bathroom facilities generally showed no significant faults to the fixtures or finishes at the time of inspection; although there was evidence of floor tiling which sounded hollow when tapped in an isolated area, which may indicate the tiles are starting to come loose, and may need to be refixed if the tiles come off. An isolated area of wall tiling has previously been re-fixed and re-grouted. (See photo no. 76, 77 & 78)

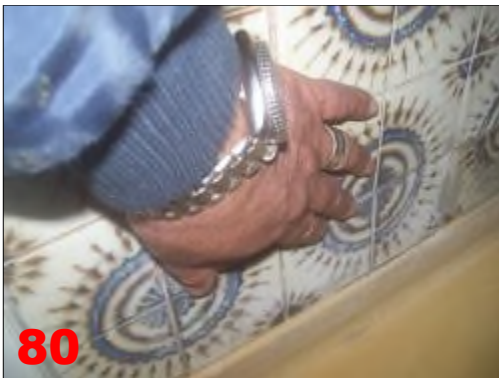
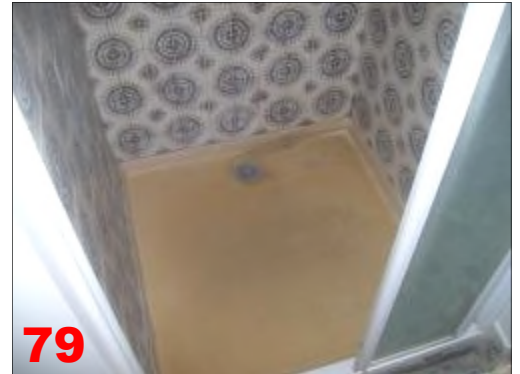
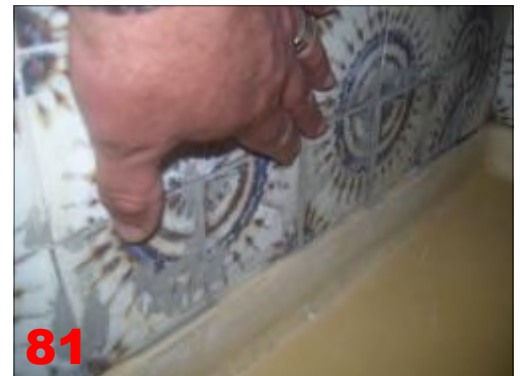
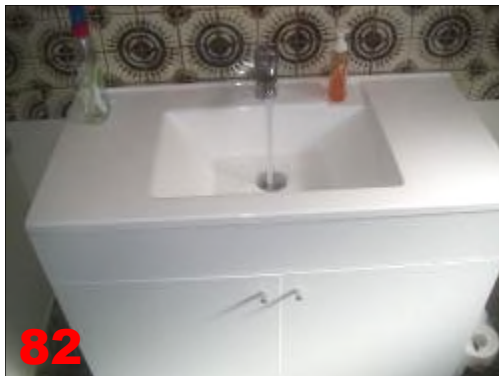
The bathroom shower showed no evidence of moisture or tiling problems at the time of inspection. (See photo no. 82 & 83)

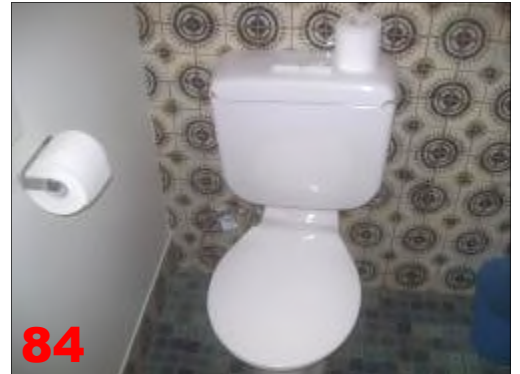
The bathroom toilet facilities were tested and found to be operable, with no evidence of leakage at the time of inspection. (See photo no. 84)

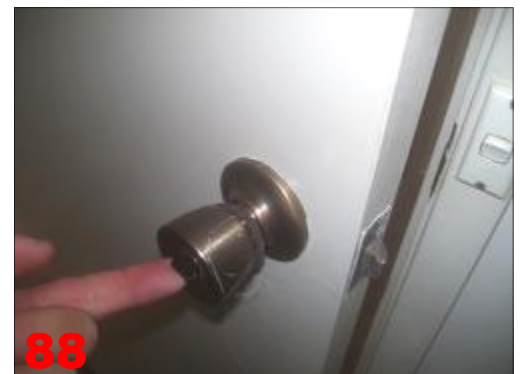
The bathroom door is fitted with a privacy lock, which was tested and found to be operable. (See photo no. 88)

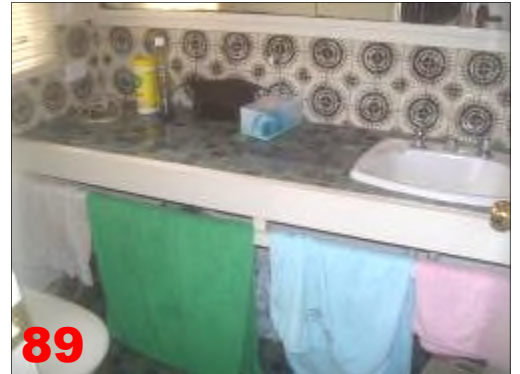
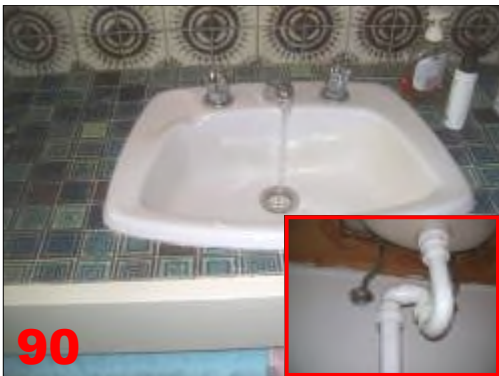
The ensuite 1 hand basin unit was tested and the plumbing found to be operable, with no evidence of leakage at the time of inspection. (See photo no. 90)

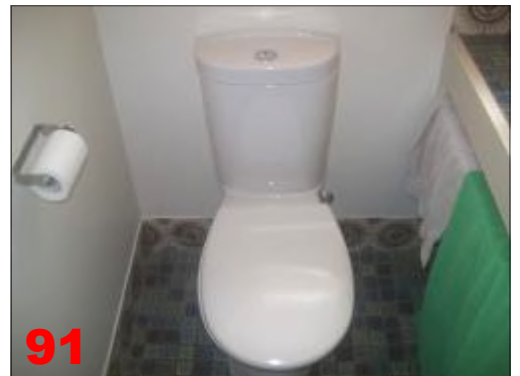
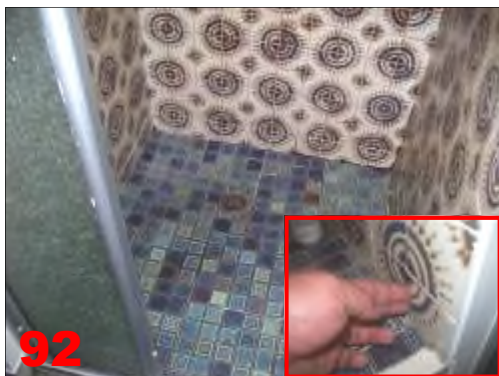
The ensuite 1 shower showed no evidence of moisture problems at the time of inspection, however there was evidence of isolated wall tiling which are staring to come loose and will need to be re-fixed if they come off. (See photo no. 92)

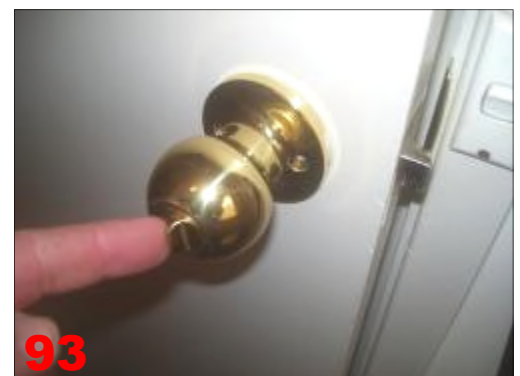
The ensuite 1 door is fitted with a privacy lock, which was tested and found to be operable. (See photo no. 93)

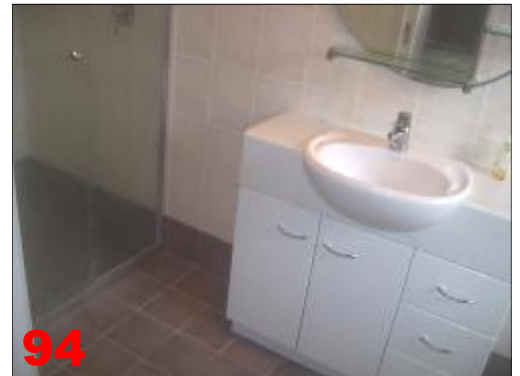
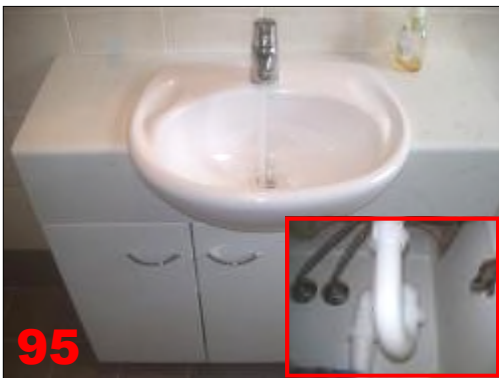
The ensuite 2 vanity unit was tested and the plumbing found to be operable, with no evidence of leakage at the time of inspection. (See photo no. 95)

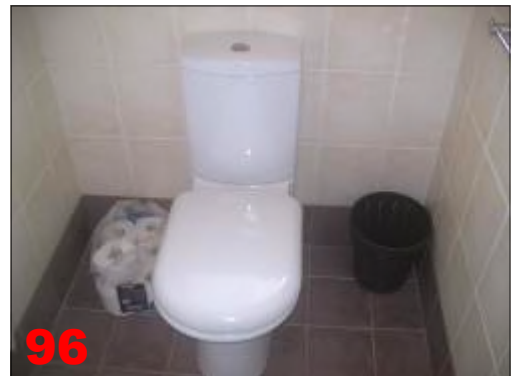
The ensuite 2 toilet facilities were tested and found to be operable, with no evidence of leakage at the time of inspection. (See photo no. 96)

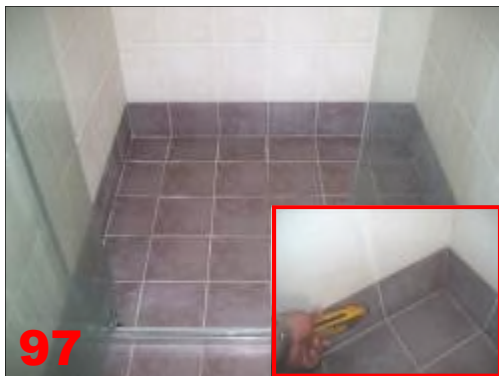
The ensuite 2 shower appeared to be in reasonable condition, although moisture meter readings in some areas indicated higher than normal moisture levels, and additional treatment may be required, but this would need to be confirmed through continued use and observation. Since the tiles were in good condition, and there was no evidence of leakage to adjoining walls, the meter may well be picking up moisture trapped between the waterproofing and the tile, which is doing no harm, and is a common occurrence, but as I said earlier, this would need to be confirmed over time. (See photo no. 97)

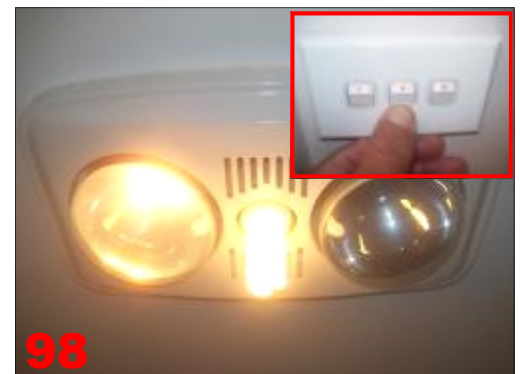
The ensuite 2 IXL Tastic appeared to be in reasonable condition, although one of the heat lamps was not operable, and may need to be replaced; and the fan function was not responsive. (See photo no. 98)

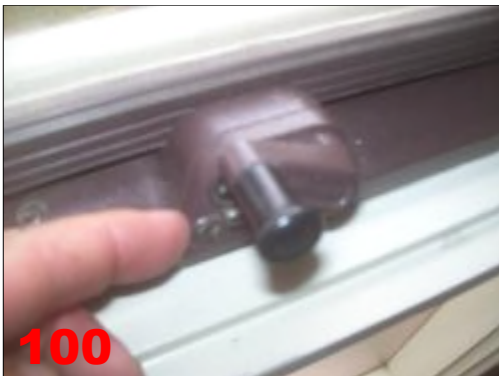
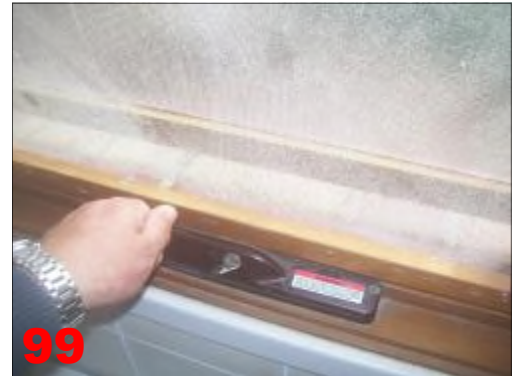
The wall mounted air-conditioning unit with remote control was operable at the time of inspection. However, a licensed technician would be required to assess the service condition of the unit as a whole. (See photo no. 101)

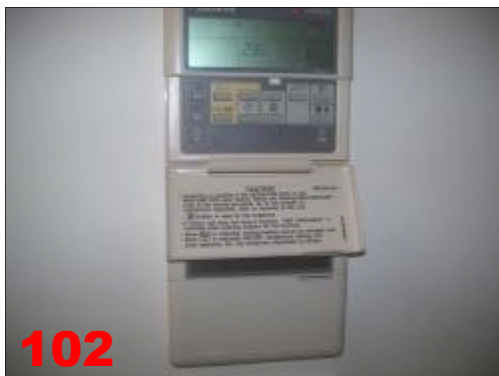
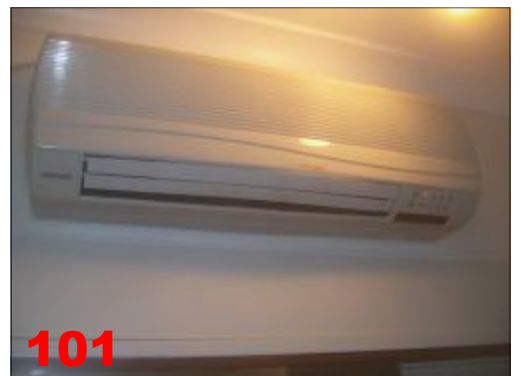
The ducted heating control panel was operable at the time of inspection. However, a licensed technician would be required to assess the service condition of the system as a whole. (See photo no. 102)

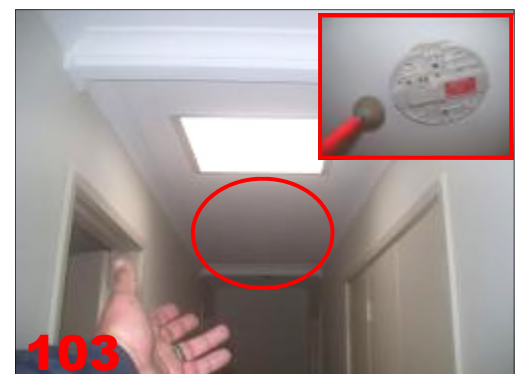
There is no smoke detector outside the four bedroom cluster, and one will need to be fitted as it is a mandatory requirement to have it in this location. The existing smoke detector has previously been removed and will require replacement as it is mandatory to have it. (See photo no. 103)

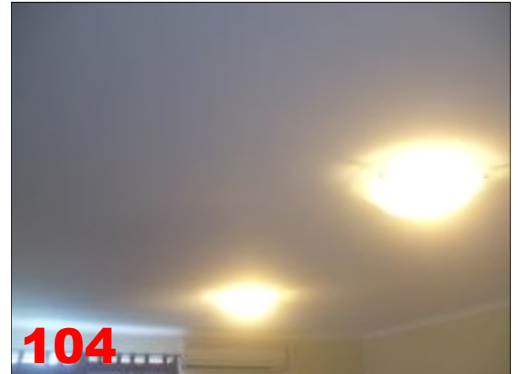
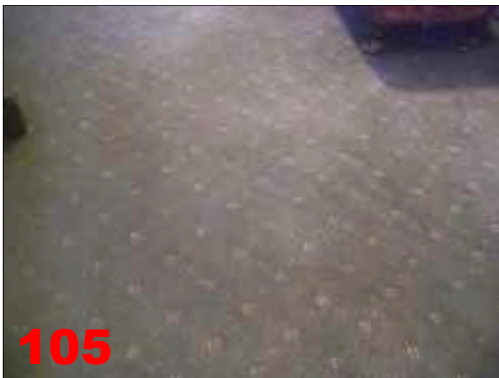
The carpet floor finishes showed no excessive staining or wear marks at the time of inspection. (See photo no. 105 & 106)

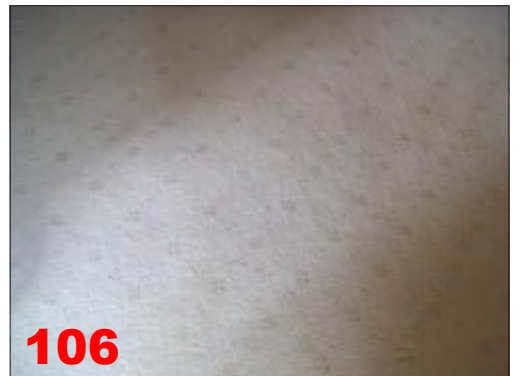
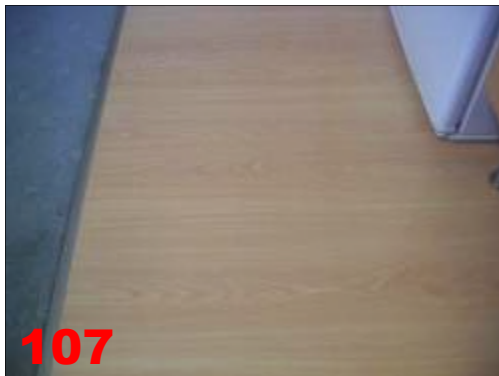
The floating timber floor finishes showed no obvious faults and no evidence of pest or water damage at the time of inspection. (See photo no. 107)

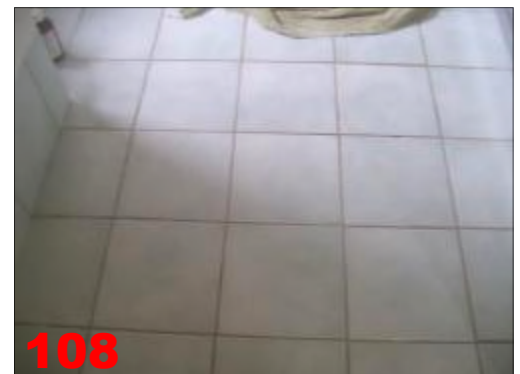
The tile floor finishes showed no excessive lifting or cracking at the time of inspection. (See photo no. 108)

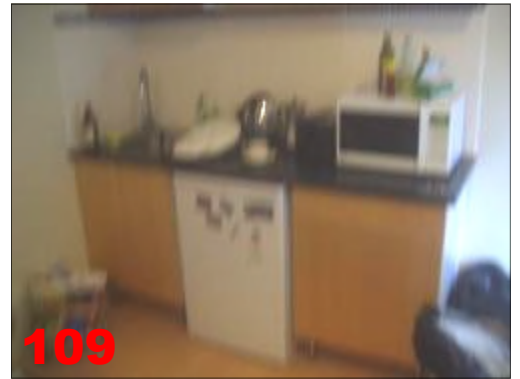
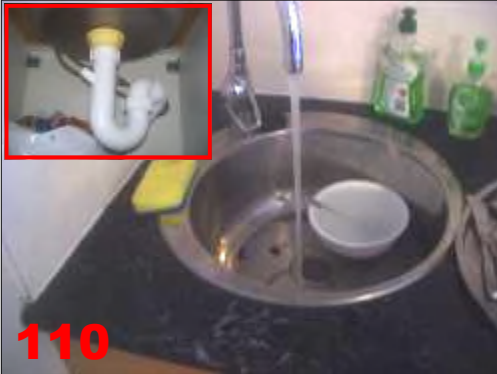
The kitchenette sink was tested and the plumbing found to be operable, with no evidence of leakage at the time of inspection. (See photo no. 110)

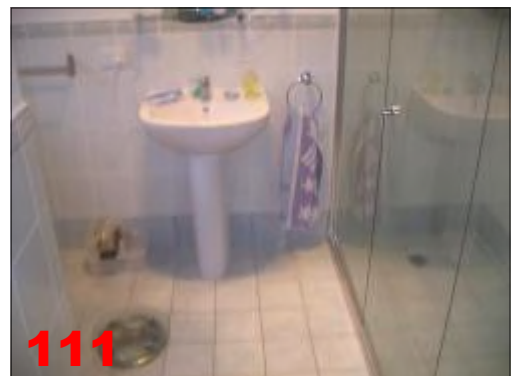
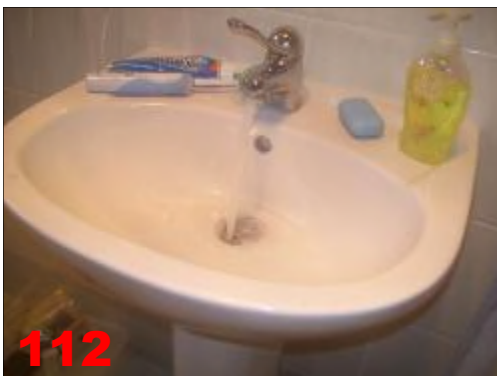
The ensuite 3 hand basin unit was tested and the plumbing found to be operable, with no evidence of leakage at the time of inspection. (See photo no. 112)

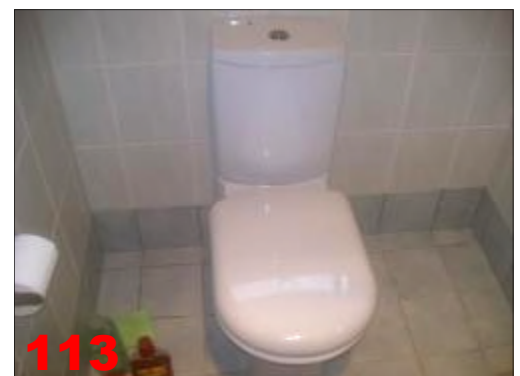
The ensuite 3 toilet facilities were tested and found to be operable, with no evidence of leakage at the time of inspection. (See photo no. 113)
