INTEGRATED BUILDING
AND INSPECTION SERVICES

WE PRIDE OURSELVES ON THE QUALITY INSPECTIONS AND REPORTS WE PRODUCE !

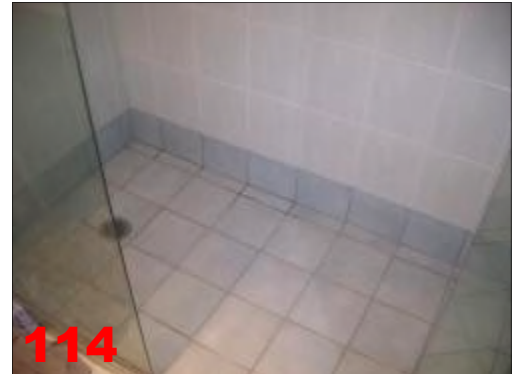
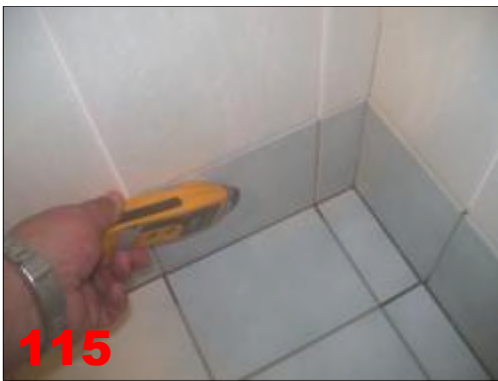
The ensuite 3 IXL Tastic appeared to be in reasonable condition, although the fan function was not responsive. (See photo no. 116 & 117)

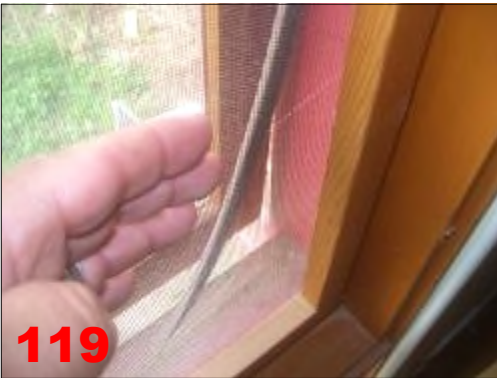
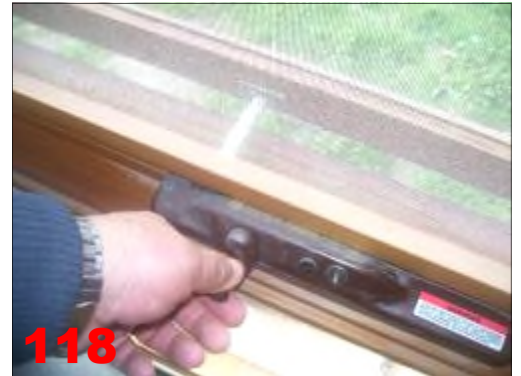
The **timber sliding doors** were operable, with no obvious faults at the time of inspection. (See photo no. 120)

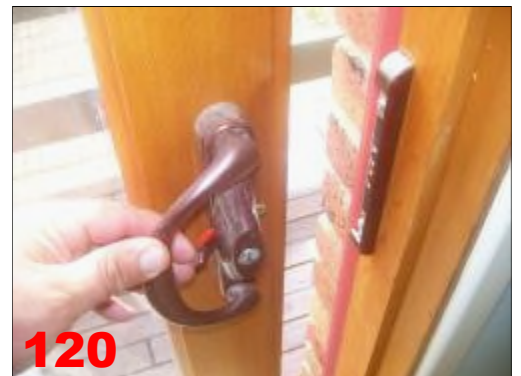
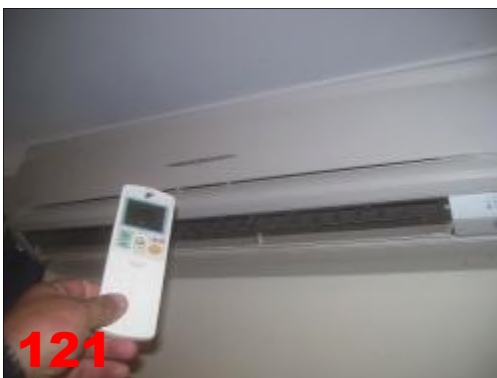
The **wall mounted air-conditioning unit with remote control** was operable at the time of inspection. However, a licensed technician would be required to assess the service condition of the unit as a whole. (See photo no. 121)

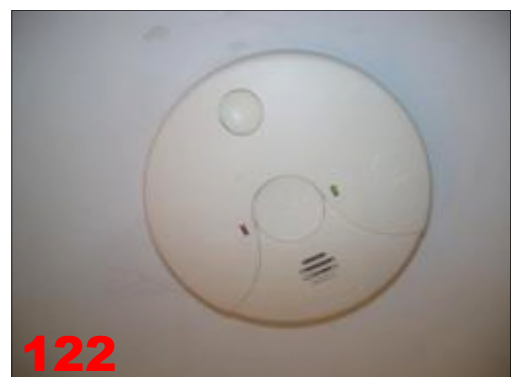
The **smoke detector** was tested and found to be operable at the time of inspection. (See photo no. 122)

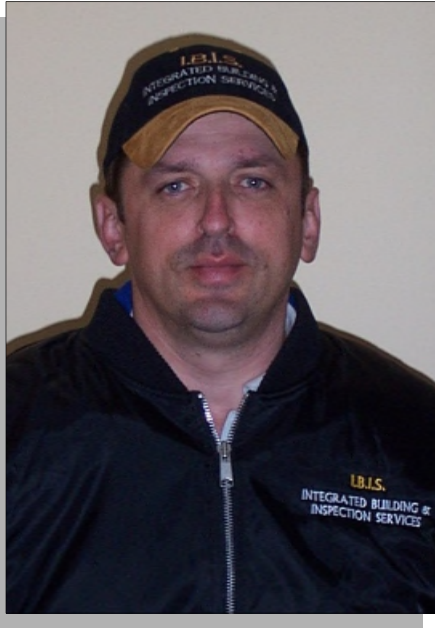
Common Questions on; Termites & Inspections.
