PEST & BUILDING

REPORT

PROPERTY ADDRESS : 57 PAUL COE CRESCENT, NGUNNAWAL ACT 2913.
BLOCK & SECTION: BLOCK 7, SECTION 126, NGUNNAWAL.
BUILDING STYLE : SINGLE STOREY, BRICK VENEER, SLAB FLOOR, TILED ROOF.
OWNER'S NAME : JOEL & NATALIE GOODISSON.
OWNER'S SOLICITOR : PETER SIMONS / GUNGALIN LEGAL SERVICES.
AGENT : ROBYN EVANS / PETER BLACKSHAW REAL ESTATE - BELCONNEN.
INSPECTOR : GEORGE PUDJA.
DATE OF INSPECTION : MONDAY 03 JUNE 2013.
REPORT NUMBER : 7035.

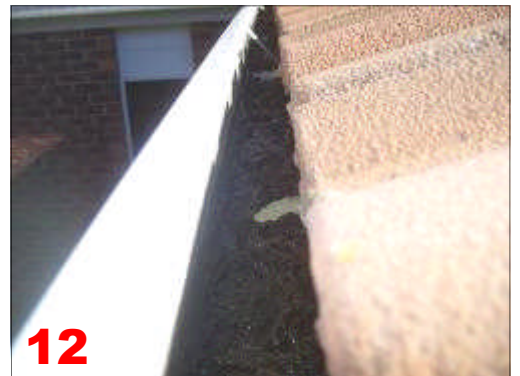
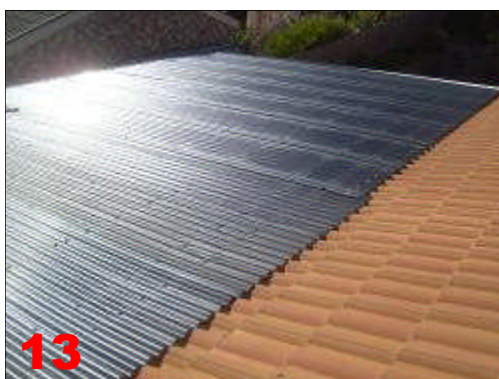
The polycarbonate roof sheeting over the front and side pergolas appeared to be in good condition, with no obvious faults at the time of inspection. It should also be noted that confirmation of whether a roof leaks or not can only be done during heavy rain. (See photo no. 13 & 14)

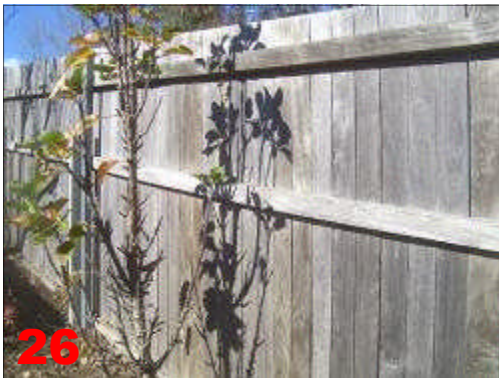
The timber fences that were unobstructed appeared to be in reasonable condition, although some sections were obscured by vines and bushes, making inspection impossible in those areas. It should also be noted that most timber fences need some maintenance and repairs, and vines may provide cover for unseen pests and periodic monitoring is recommended. All timber elements in contact with the ground are susceptible to pest and water problems and should be monitored on a regular basis. (See photo no. 26 & 27)

- **Where timber fences other timber elements** are in contact with the ground, they become susceptible to termites and other pests, particularly where decay has already set in, and although no activity was found during the inspection, that is not a guarantee that this could not happen at some point in the future, and periodic monitoring is recommended.

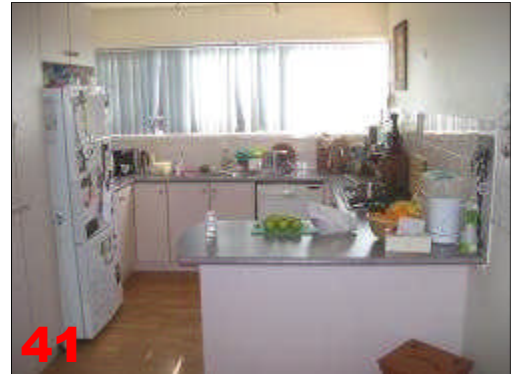
The kitchen facilities showed no significant faults to the fixtures or finishes at the time of inspection. (See photo no. 41)

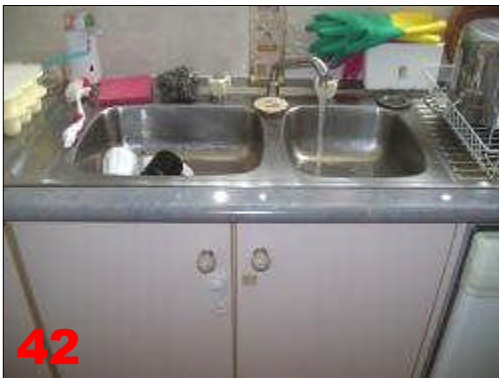
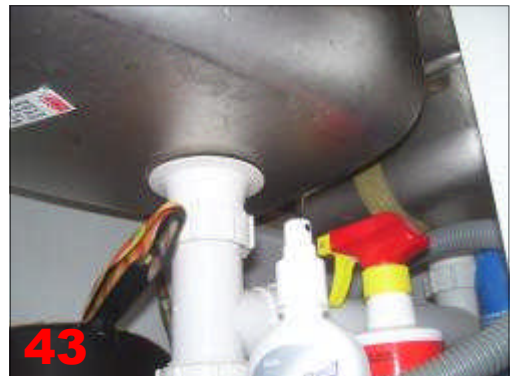
The kitchen sink was tested and the plumbing found to be operable, with no evidence of leakage at the time of inspection. (See photo no. 42 & 43)

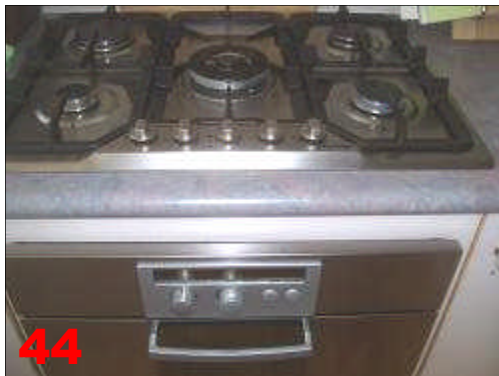
The kitchen appliances were operable when tested at the time of inspection. (See photo no. 44)

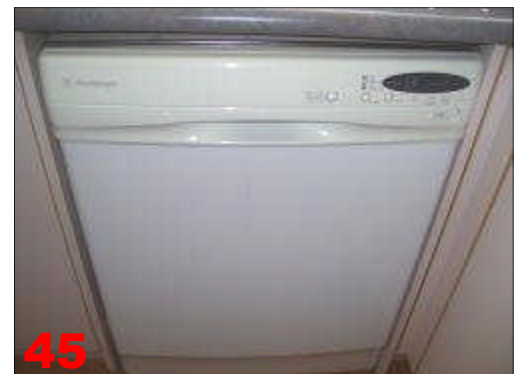
The dishwasher showed no evidence of leakage and no excessive cracking to the door seal, although the unit was not tested at the time of inspection. (See photo no. 45)

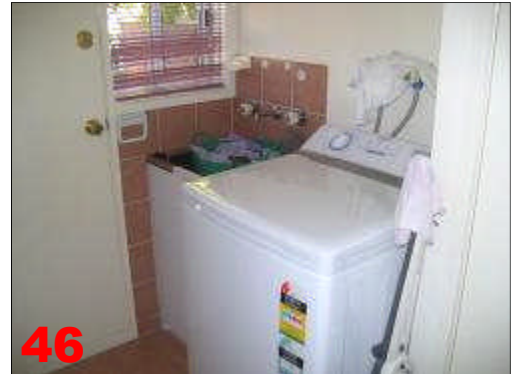
The laundry facilities showed no significant faults to the fixtures or finishes at the time of inspection. (See photo no. 46)

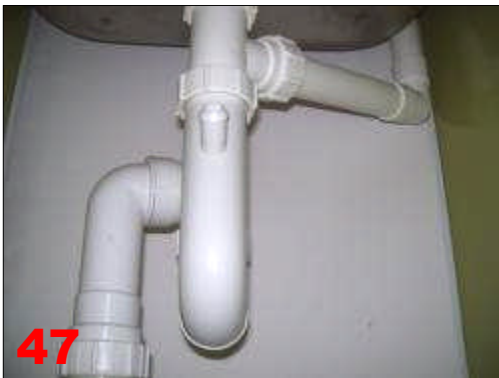
The laundry tub was tested and the plumbing found to be operable, with no evidence of leakage at the time of inspection. (See photo no. 47)

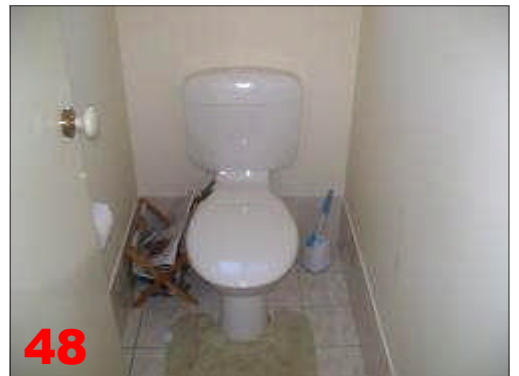
The toilet facilities were tested and found to be operable, with no evidence of leakage at the time of inspection. (See photo no. 48)

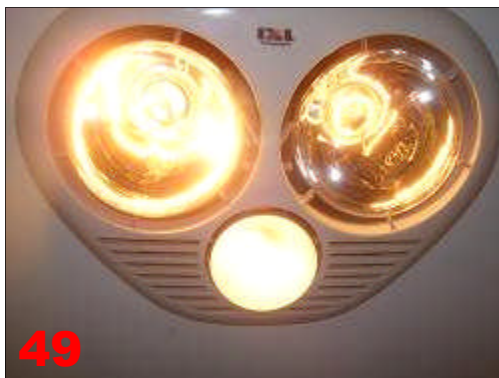
The toilet IXL Tastic was operable when tested at the time of inspection. (See photo no. 49)

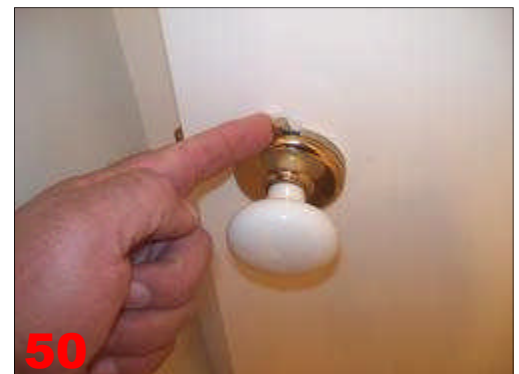
The toilet door is fitted with a privacy lock that was tested and found to be operable. (See photo no. 50)

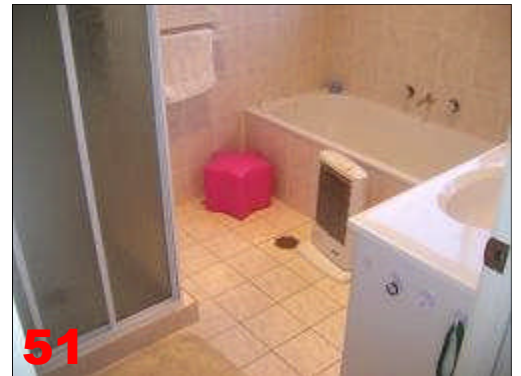
The bathroom facilities showed no significant faults to the fixtures or finishes at the time of inspection. (See photo no. 51)

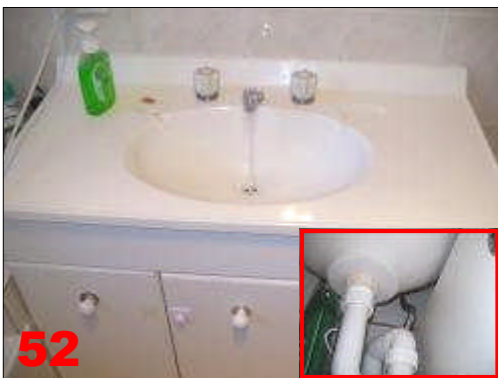
The bathroom vanity unit was tested and the plumbing found to be operable, with no evidence of leakage at the time of inspection. (See photo no. 52)

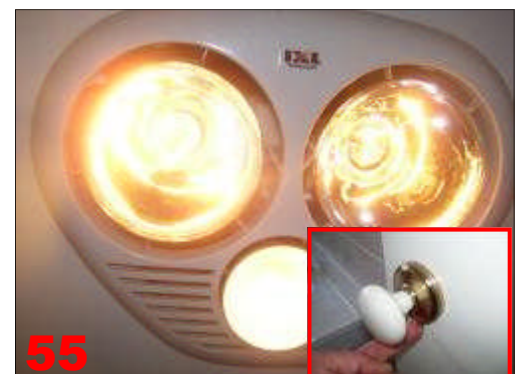
The bathroom IXL Tastic was operable when tested at the time of inspection. The bathroom door is fitted with a privacy lock, which was tested and found to be operable. (See photo no. 55)

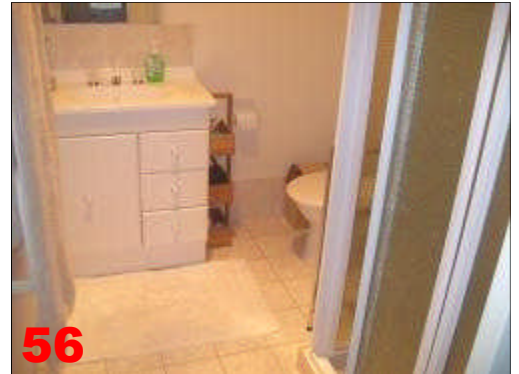
56

The ensuite facilities showed no significant faults to the fixtures or finishes at the time of inspection. (See photo no. 56)

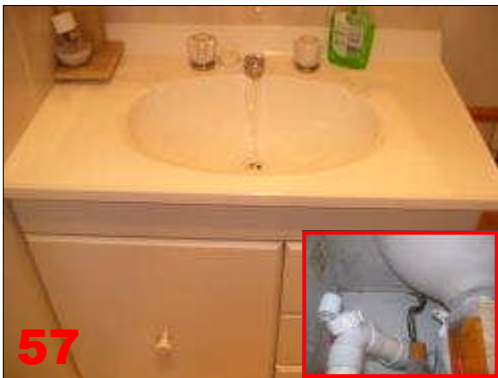
57

The ensuite vanity unit was tested and the plumbing found to be operable, with no evidence of leakage at the time of inspection. (See photo no. 57)

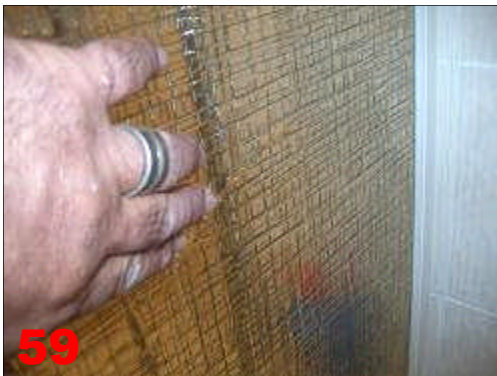
The ensuite shower showed no evidence of moisture or tiling problems at the time of inspection. The glass to the shower screen was cracked and although it did not appear to be loose, it may require replacement. The shower screen doors were operable, but the centre door is missing a clip that prevents the doors sliding past on another, but this could be easily rectified. (See photo no. 58, 59 & 60)

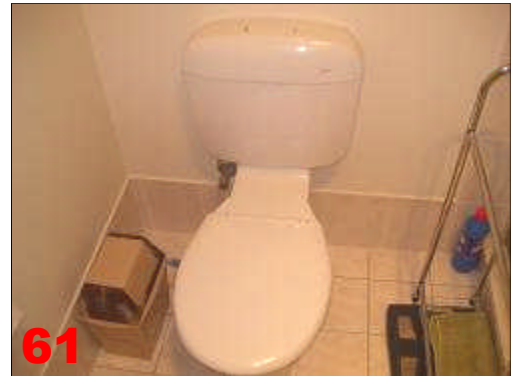
61

The ensuite toilet facilities were tested and found to be operable, with no evidence of leakage at the time of inspection. (See photo no. 61)

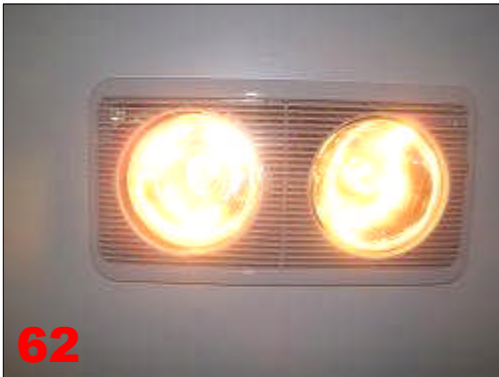
62

The ensuite IXL Tastic was operable when tested at the time of inspection. (See photo no. 62)

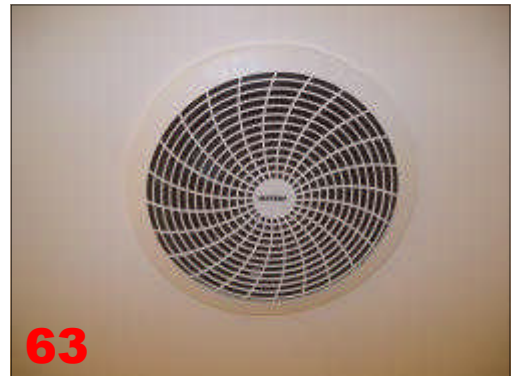
63

The ensuite exhaust fan was operable when tested at the time of inspection. (See photo no. 63)

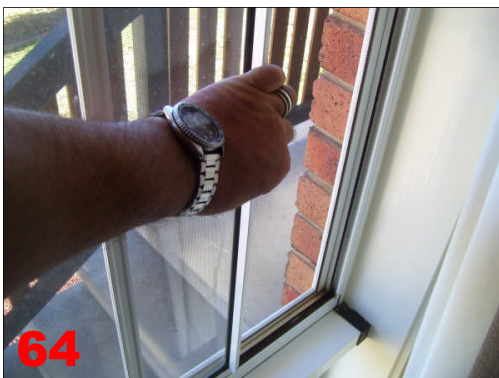
64

The aluminium windows showed no significant faults at the time of inspection. (See photo no. 64)

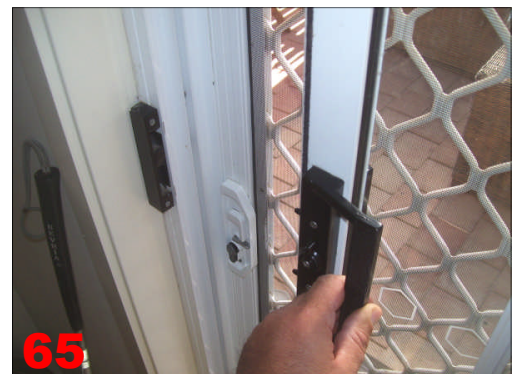
65

The aluminium sliding door was operable with no obvious faults at the time of inspection. (See photo no. 65)

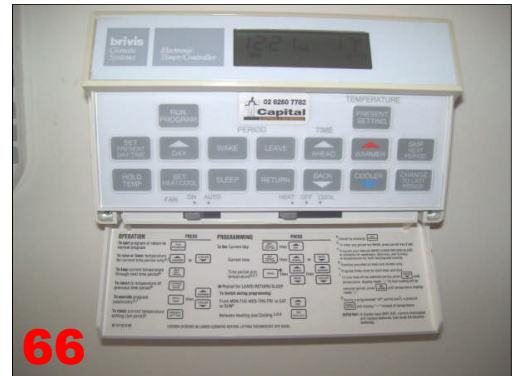
The ducted heating control panel was operable at the time of inspection. However, a licensed technician would be required to assess the service condition of the system as a whole. (See photo no. 66)

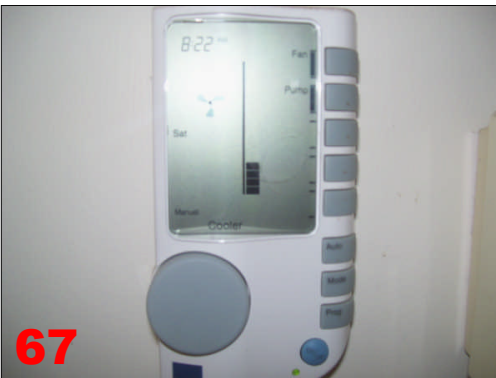
The air-conditioning control panel was operable at the time of inspection. However, a licensed technician would be required to assess the service condition of the system as a whole. (See photo no. 67)

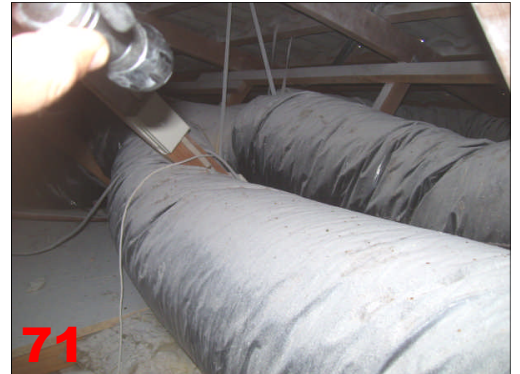
Access was restricted to most sections of the roof space due to the number and size of the heating/cooling ducts, and therefore no comment can be made regarding the condition of those areas. (See photo no. 71)

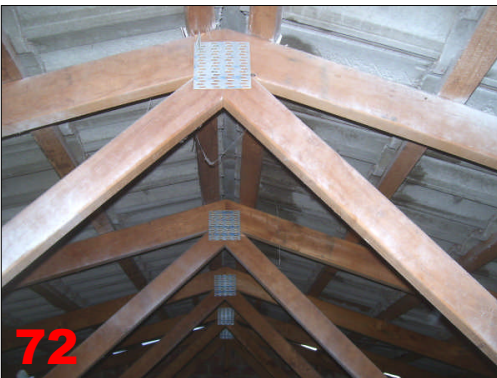
The roof structure is a truss roof design; the trusses appeared to be well set out and fixed, and showed no significant structural, pest or water damage to the trusses that could be accessed and inspected at the time of inspection. (See photo no. 72)

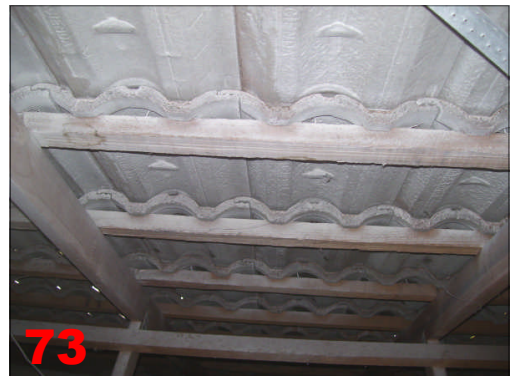
The roof battens appeared to be in good condition, with no evidence of excessive sagging or water damage to the battens that could be accessed and inspected at the time of inspection. (See photo no. 73)

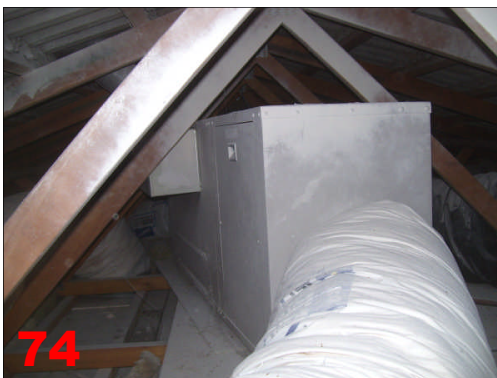
The ducted heating unit is located in the roof space, and showed no obvious faults externally at the time of inspection. However, a licensed technician would be required to assess the service condition of the system as a whole. (See photo no. 74)

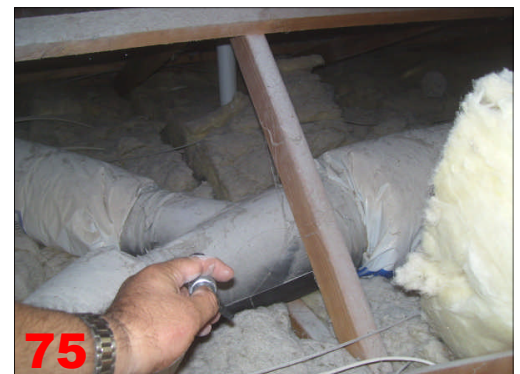
The heating and cooling ducts that could be accessed and inspected showed no evidence of gaps or leakage at the junctions at the time of inspection. (See photo no. 75)

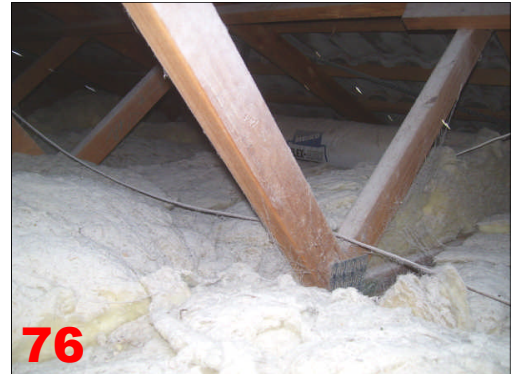
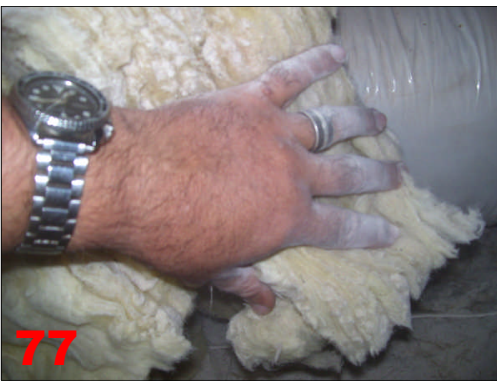
The ceiling is fully insulated with fibreglass batts throughout, although the batts were not lifted during the inspection, which means the batts restrict a clear view of the ceiling structure, therefore not all areas were able to be inspected, particularly where height is restricted due to the slope of the roof or the number and size of ducting. **Please note:** I don't recall seeing any downlights fitted in this residence, but should down lights be fitted; care should be taken to ensure a 100mm clearance between the light and surrounding insulation or fitting a shroud to reduce a risk of fire.
(See photo no. 76 & 77)
