**BUILDING INSPECTION REPORT  
COMPLIANCE INSPECTION REPORT  
TIMBER PEST INSPECTION REPORT  
ENERGY RATING REPORT**

Prepared in accordance with AS4349.0 and AS4349.1-2007

**33 Louisa Briggs Circuit Bonner**

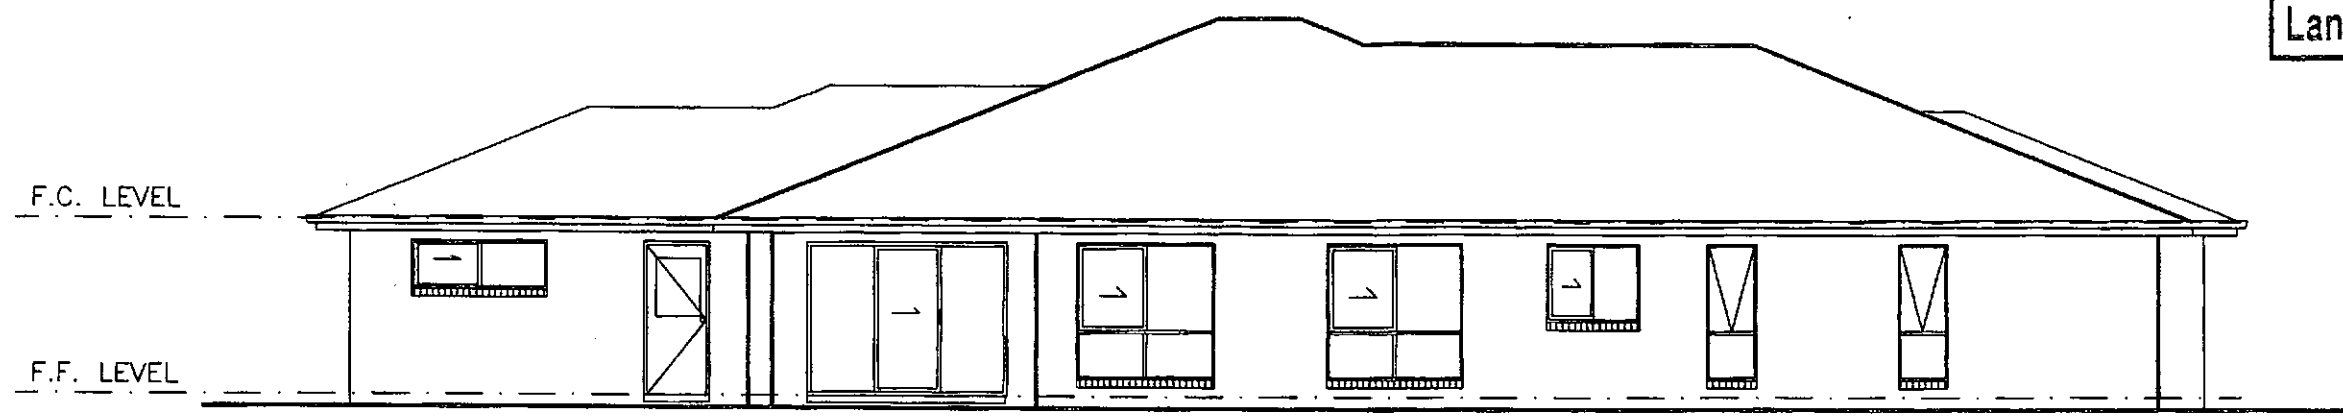
BACK ELEVATION

SELECT CONC. ROOF TILES  
ALUMINIUM WINDOWS & DOORS  
FACE BRICKWORK
