50a Darwinia Terrace CHAPMAN ACT

Pre-Purchase Inspection - Residential Building Report – (ACT)

**Complies with Australian Standard AS 4349.1- 2007 Inspection of Buildings Part 1:
Pre-Purchase inspections – Residential buildings – Appendix “C”**

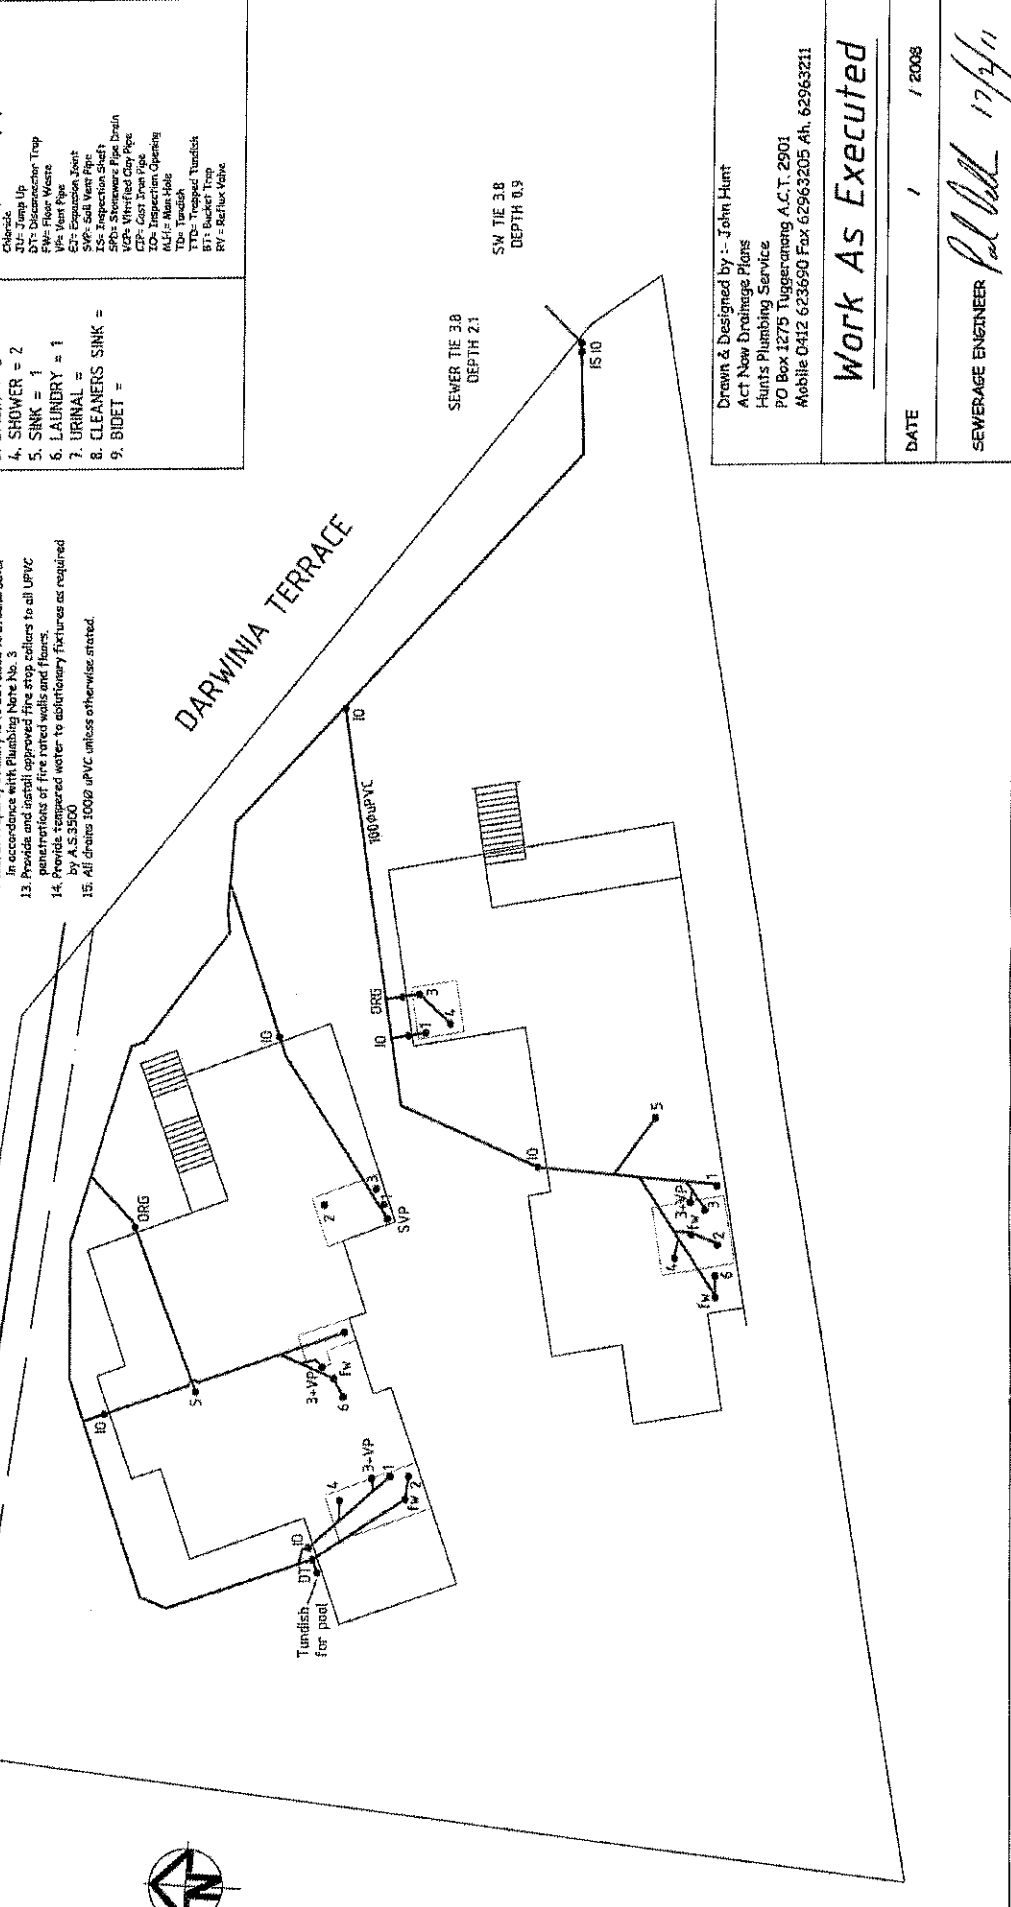
Work As Executed

- Provide and install approved fire stop collars to all UPVC penetrations of fire rated walls and floors.
 - Provide tempered water to ablutionary fixtures as required by A.S.3500

- All drains 100/180 UPVC unless otherwise stated.
