**BUILDING INSPECTION REPORT  
COMPLIANCE INSPECTION REPORT  
TIMBER PEST INSPECTION REPORT  
ENERGY RATING REPORT**

Prepared in accordance with AS4349.0 and AS4349.1-2007

**56 Overall Avenue Casey**

PROPOSED RESIDENCE		BLOCK: 24	SECTION: 18	SUBURB: CASEY	FOR: POISE PTY. LTD.

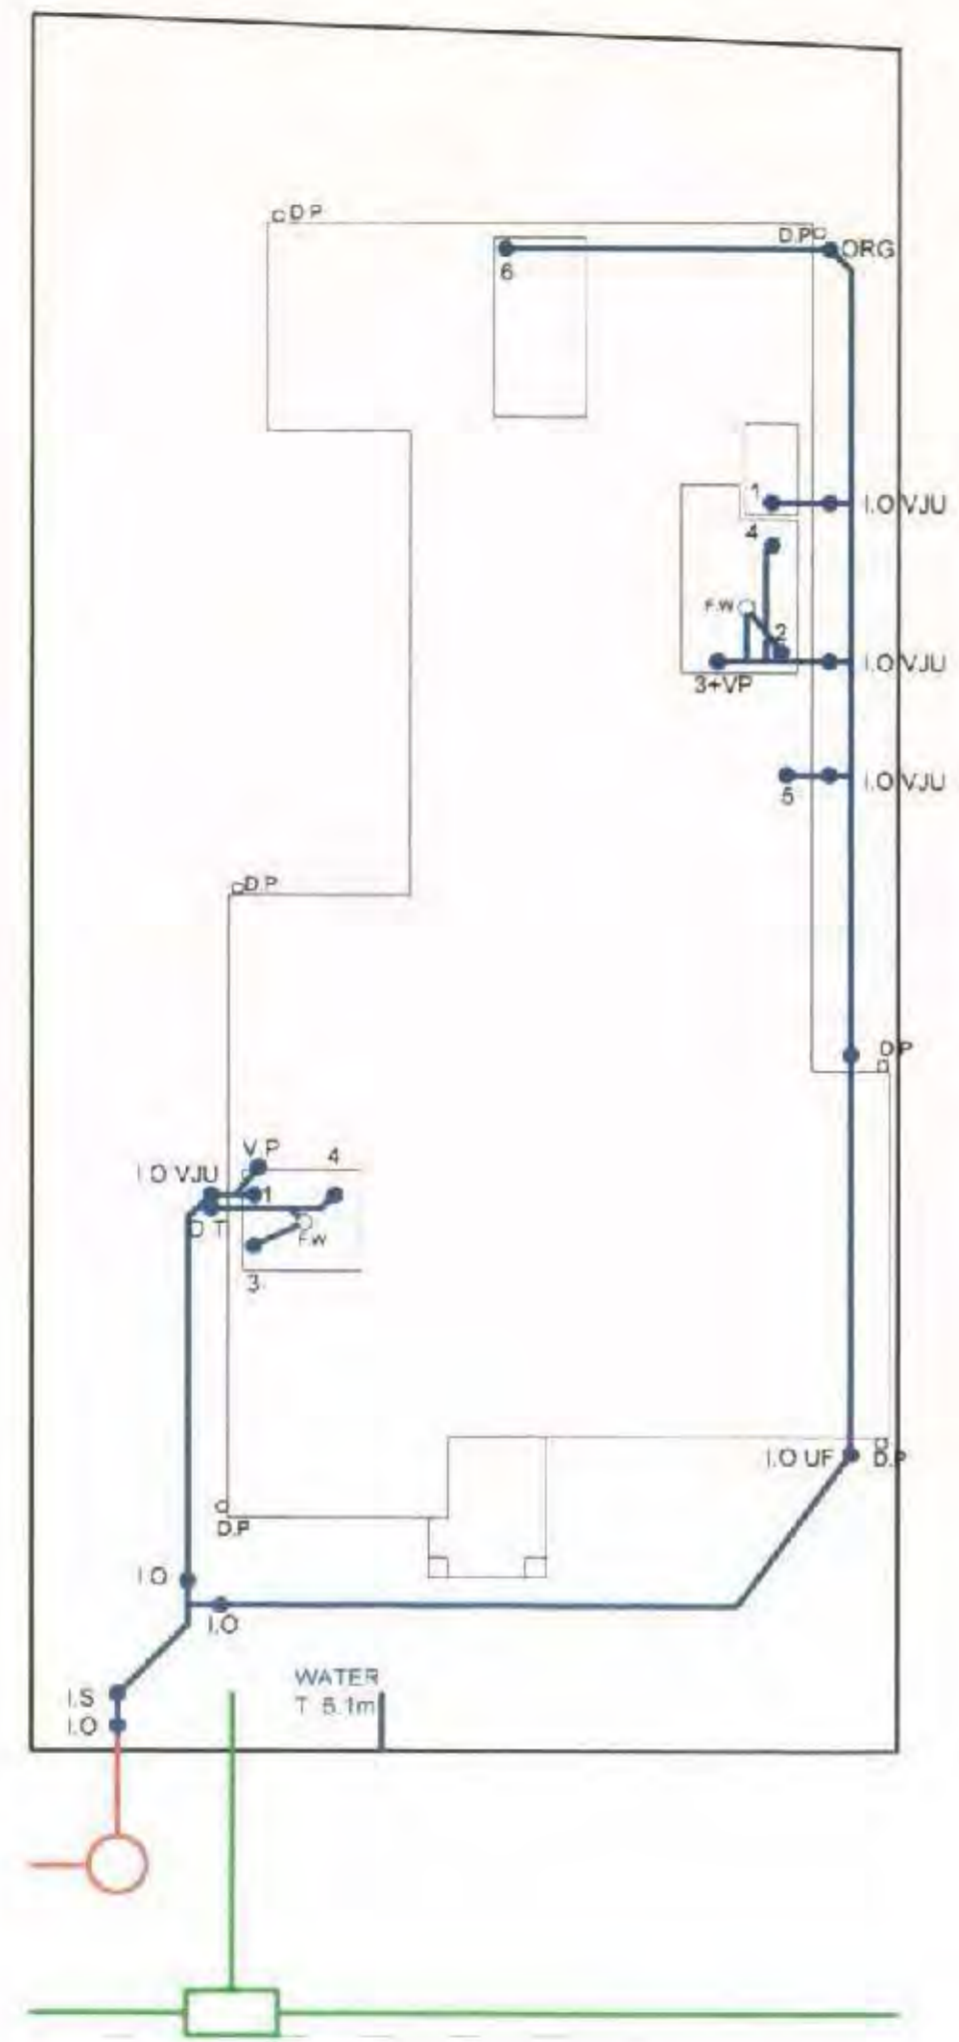
SEWER TIE  
 T 1.5m  
 D 2.0m  
 CH MH

S/WATER TIE  
 T 3.5m  
 D 1.3m  
 CH SUMP
