STANDARD BUILDING REPORT
STANDARD TIMBER PEST REPORT
COMPLIANCE REPORT
ENERGY EFFICIENCY RATING

6 Ikara Close
DUNLOP ACT, 2615

Our Ref: 17940

Date: 19/08/2013

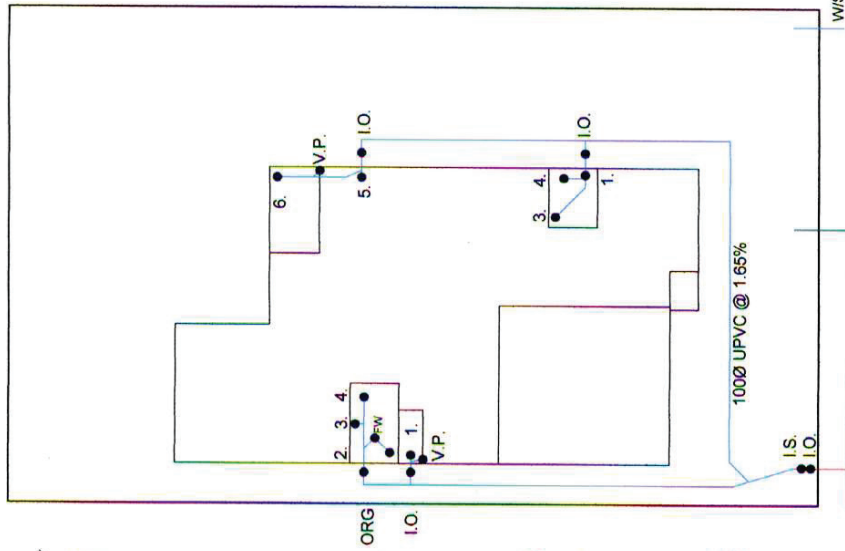
- Drains under Building must be retested, if test failed then old drain must be replaced using either RRJVC or UPVC pipe material.
- Connection to existing main/manhole to be made by A.C.T.E.W. at Contractor's expense.

- O.R.G. Top to be minimum 150mm below lowest graded fitting with a further 10mm from top to paving level or a further 75mm from top to unpaved ground level.

- I.S. at Property Boundary is to be raised to Ground Level in accordance with plumbing Note No.3.
- Provide and install approved fire stop collars to all U.P.V.C. Penetrations of fire rated walls and floors.

STORMW
CH. 0.0
T. 8.2
D. 1.5

SEWERAGE
CH. 42.4
T. 1.4
D. 2.0
