STANDARD BUILDING REPORT
STANDARD TIMBER PEST REPORT
COMPLIANCE REPORT
ENERGY EFFICIENCY RATING

24 Inglewood Street
GUNGAHLIN ACT, 2912

CONCLUSION

COMPLIANCE CERTIFICATE

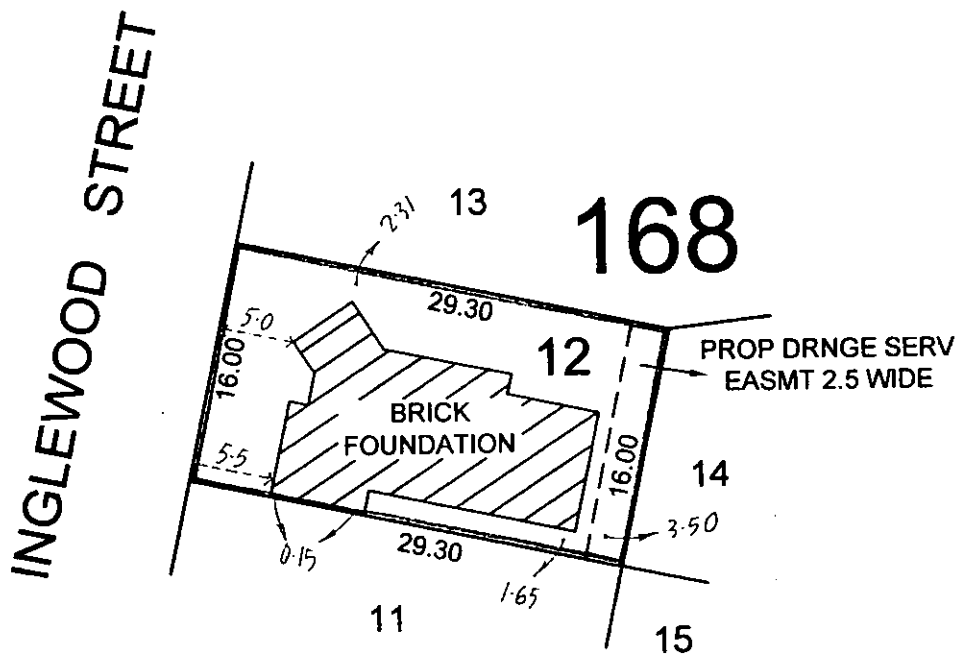
Upon this land stands the brick foundation of a residence in the course of erection. The position of this brickwork in relation to the boundaries of the land is shown on the sketch plan endorsed hereon.

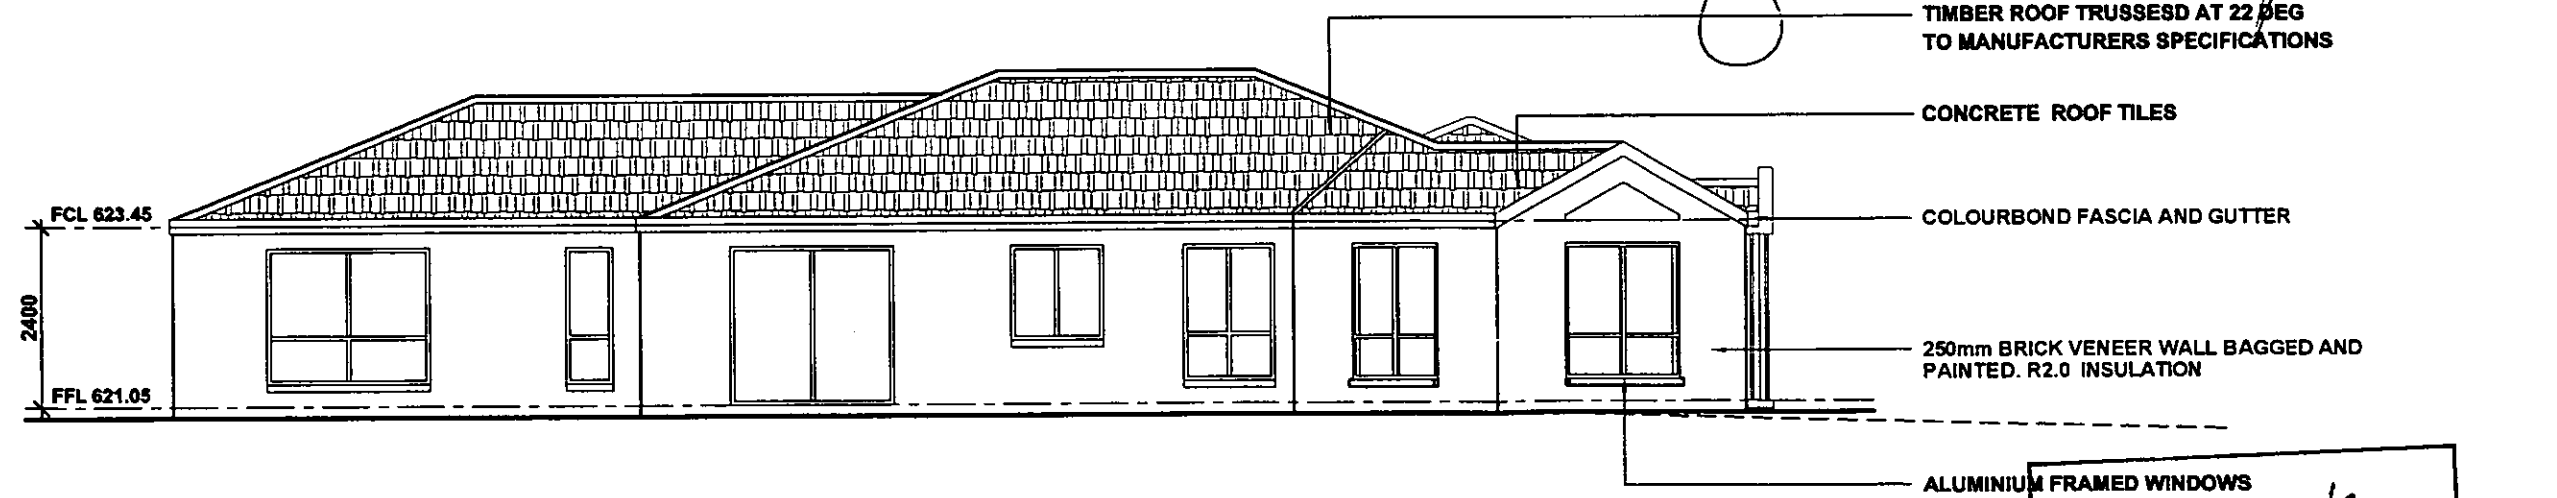
NORTH ELEVATION

ALUMINIUM FRAMED WINDOWS
Plan No: 02796/A.
7 MAR 2002
Received BEPCON
Planning and Land Management
