ETHICAL BUILDING AND PEST SERVICES

**39 Jemalong Street
DUFFY ACT**

Pre-Purchase Inspection - Residential Building Report – (ACT)

**Complies with Australian Standard AS 4349.1- 2007 Inspection of Buildings Part 1:
Pre-Purchase inspections – Residential buildings – Appendix “C”**

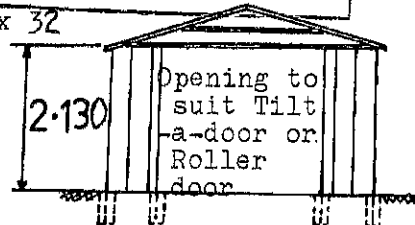
FRONT ELEVATION

End Wall Column for
3.90 Garages only
