**51 Bendigo Street  
FISHER ACT**

## **Pre-Purchase Inspection - Residential Building Report – (ACT)**

**Complies with Australian Standard AS 4349.1- 2007 Inspection of Buildings Part 1:  
Pre-Purchase inspections – Residential buildings – Appendix “C”**

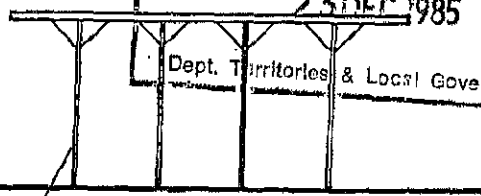
SIDE ELEVATION

FASCIA GUTTER  
ZINCALUME
